Preserving Haiti's Gingerbread Houses

2010 Earthquake Mission Report

A World Monuments Fund / ICOMOS Project funded in part by Prince Claus Fund and FOKAL

**2010 Earthquake Mission Report
December 2010**

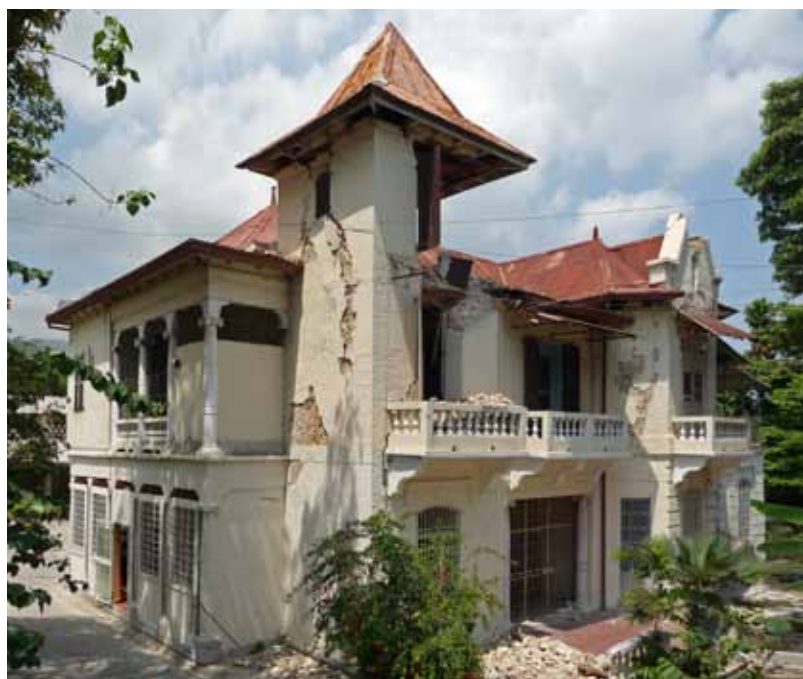
FIGURE 3 The Catholic seminary at 110 Rue Fleur Du Cheine. This masonry bearing-wall structure exhibits partial collapse of corner tower.

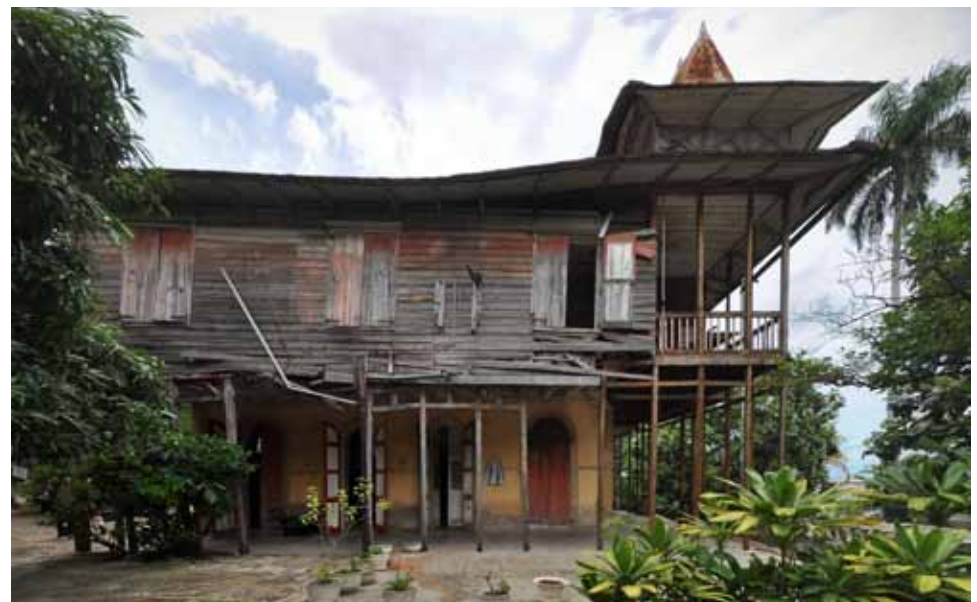
FIGURE 65: The Patrice Pamphile House (shown also in Figures 2 and 32) showing the heavily deteriorated wooden part of the structure, which at one time probably had been an open porch.

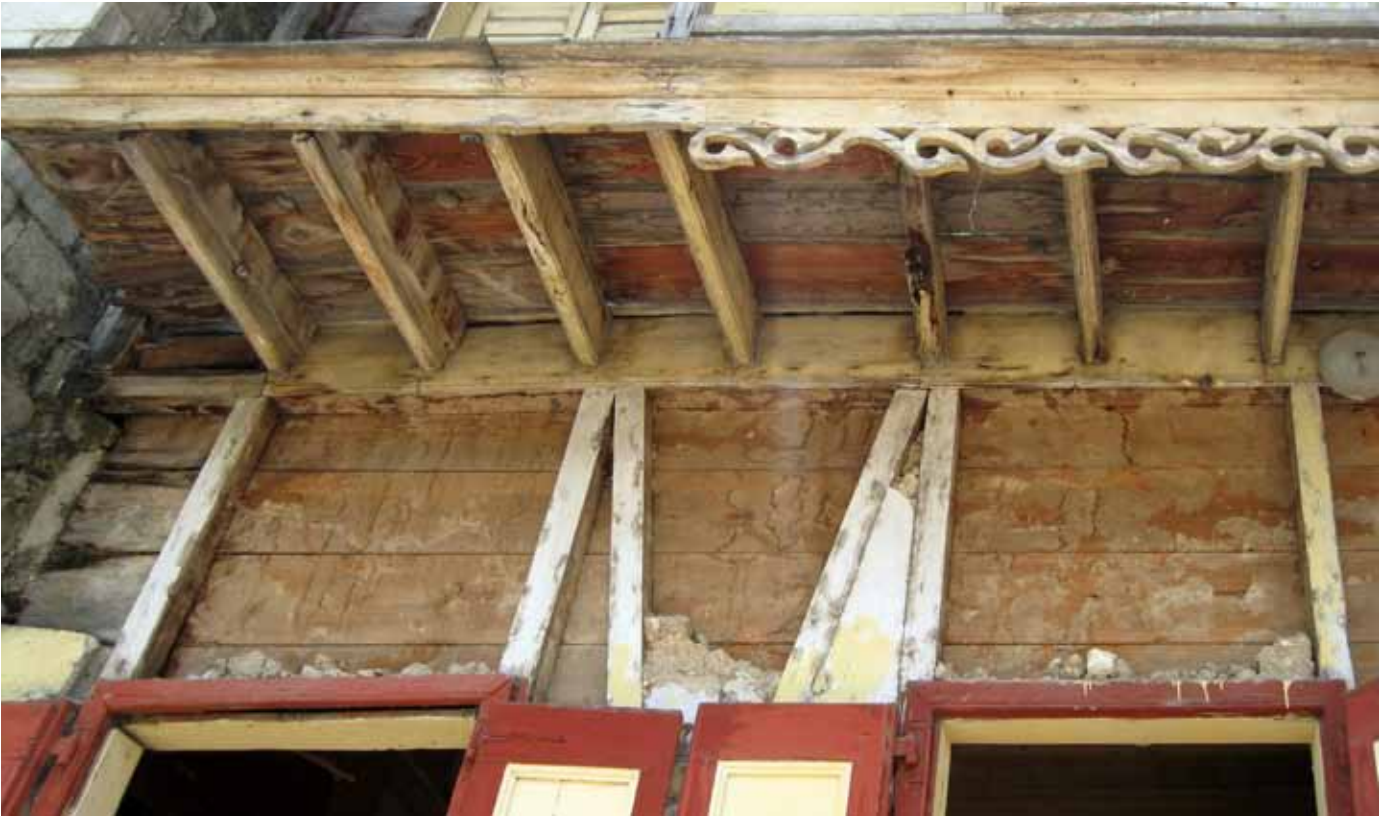
FIGURE 66 Some houses have cantilever balconies. These are vulnerable to decay at the critical location where the beams enter the wall.

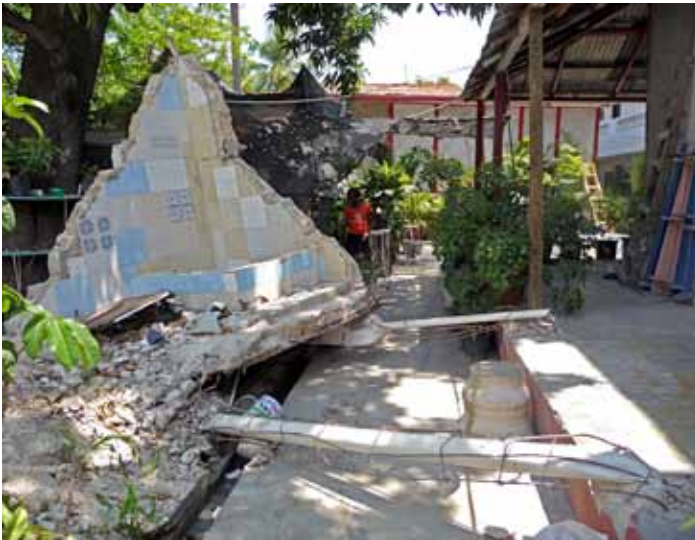
FIGURE 70 This second floor concrete bathroom addition at 5 Lamartiniere landed on the ground after its concrete columns buckled as it pulled away from its parent Gingerbread house. Note sewer pipes in the center of the rebar of the buckled columns.

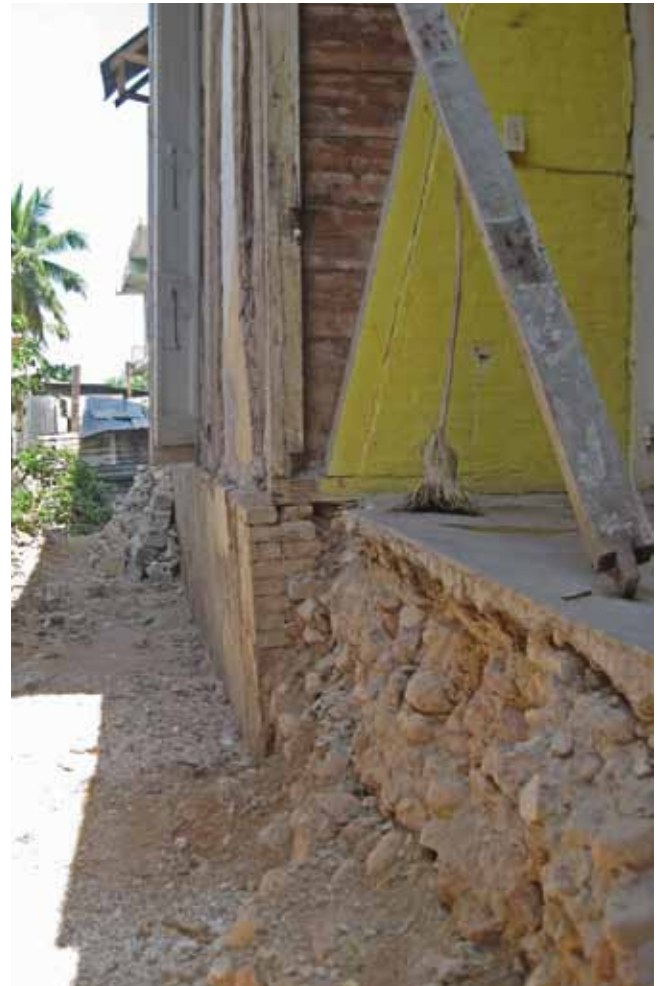
FIGURE 71 A portion of the foundation wall has collapsed at the house at 2 Avenue N, revealing that the crawl space below the first floor had been filled with rubble and the wood floor had been replaced with a slab on grade. Lateral loads on the wall from the fill caused it to collapse. The foundation wall remaining has rotated outward.

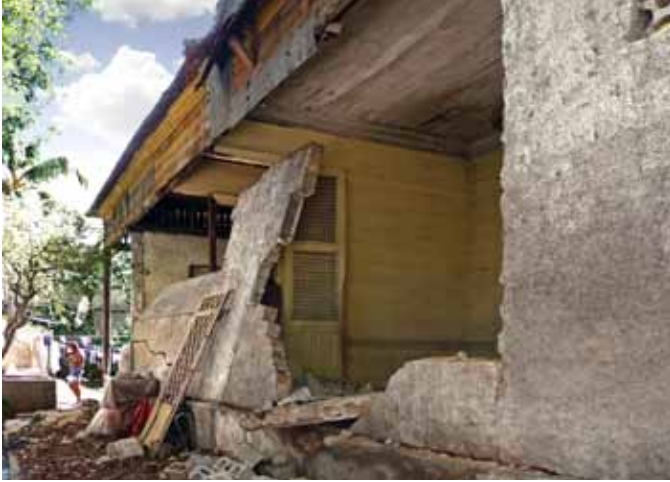
FIGURE 72 A replacement side wall of concrete block at 19 Lamar-tiniere suffered partial collapse.

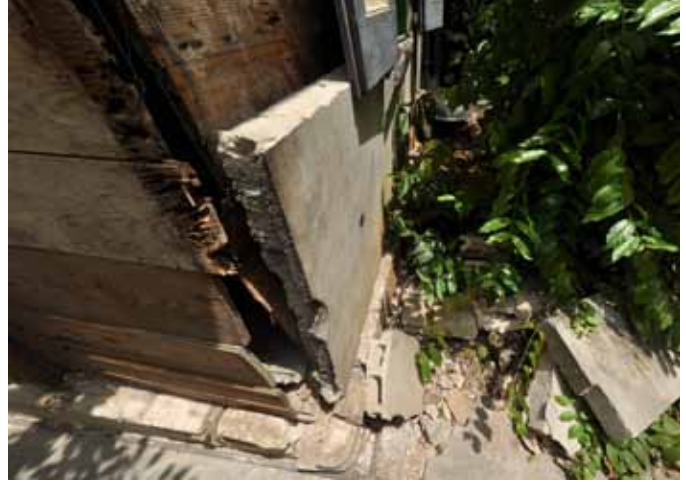
FIGURE 73 These are examples of *colomage* where the rubble infill has been replaced with concrete. This has accelerated the rotting of the timber framing, which then broke during the earthquake causing the collapse of the heavy concrete infill.

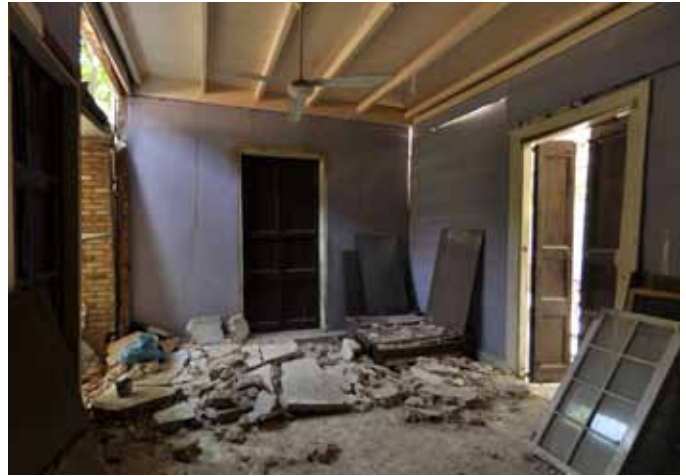
FIGURE 74 Improper repair of stone infill of *colomage* using cement mortar. These repairs would render a fill that was much harder and solid than the fill that it replaced.

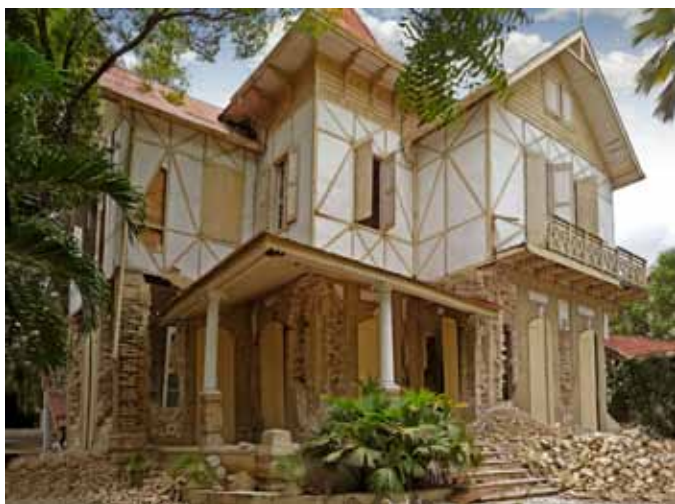
FIGURE 77 The Dufort House, a hybrid structure, exhibited substantial damage to the masonry first-story walls, including its limestone panels and brick piers, but significantly less damage to its *colombage* and wood frame second-story walls. Notwithstanding the increased seismic loads on the first-floor walls, the difference in performance of the systems is indicative of a tendency seen throughout the surveyed buildings.

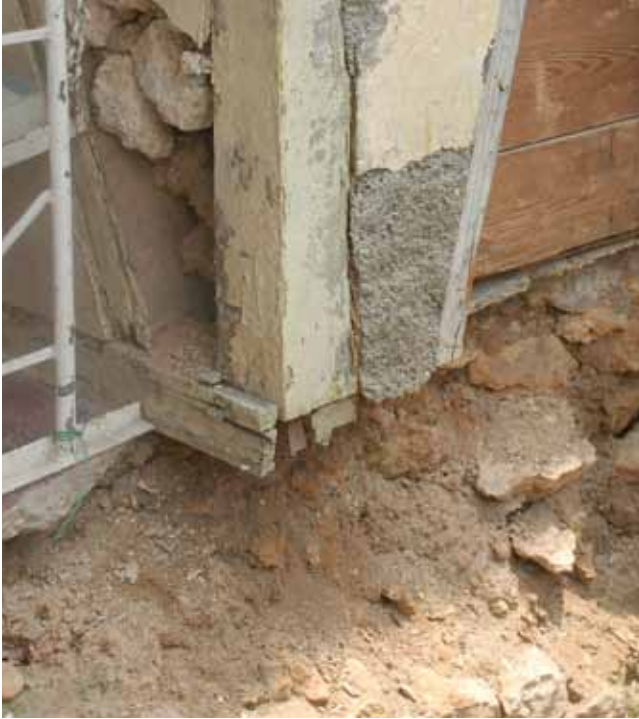
FIGURE 79 The wood sill that was previously termite damage crushed during the earthquake causing the entire structure to settle on its foundation. The result is that many of the doors to the exterior cannot be opened or closed.

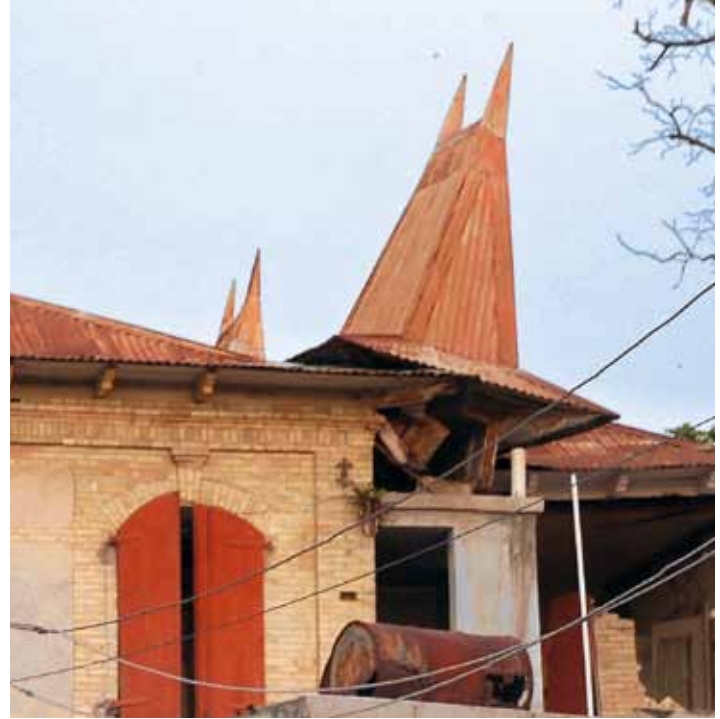
FIGURE 80 Both of the steeples of this Gingerbread house were shaken out of plumb during the earthquake.

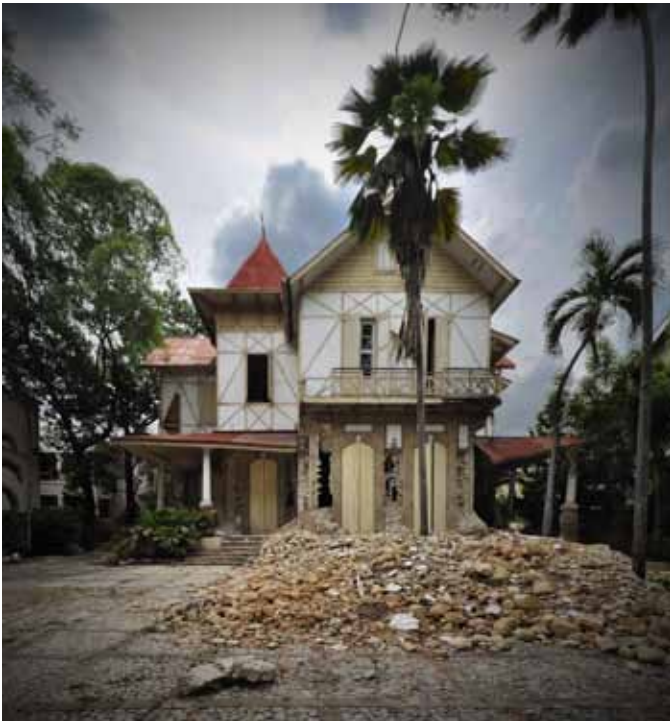
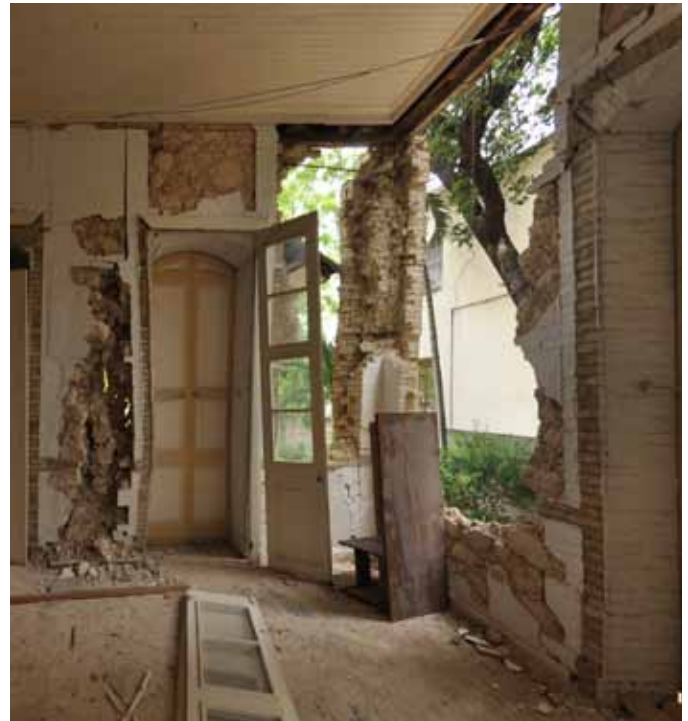
FIGURE 95 *above left* The Dufort House showing the collapse of the rubble panels, leaving the piers standing holding up the almost undamaged upper floor structure. The remarkably large pile in front shows the volume of rubble masonry removed from the house after it had collapsed. *above right* The interior of the Dufort House, also shown in Figure 77, showing how the collapse of the rubble panels left the house standing on the brick piers which were left like free standing columns. *left* This house also had steel or wrought iron reinforcing chains made up of rods hooked together for the full length of the exterior and major interior walls. In this case, rather than exterior plates to hold them, their wall anchors were imbedded under the outer wythe of masonry. The rods are also visible where they intersect at the corner pier that is still standing.

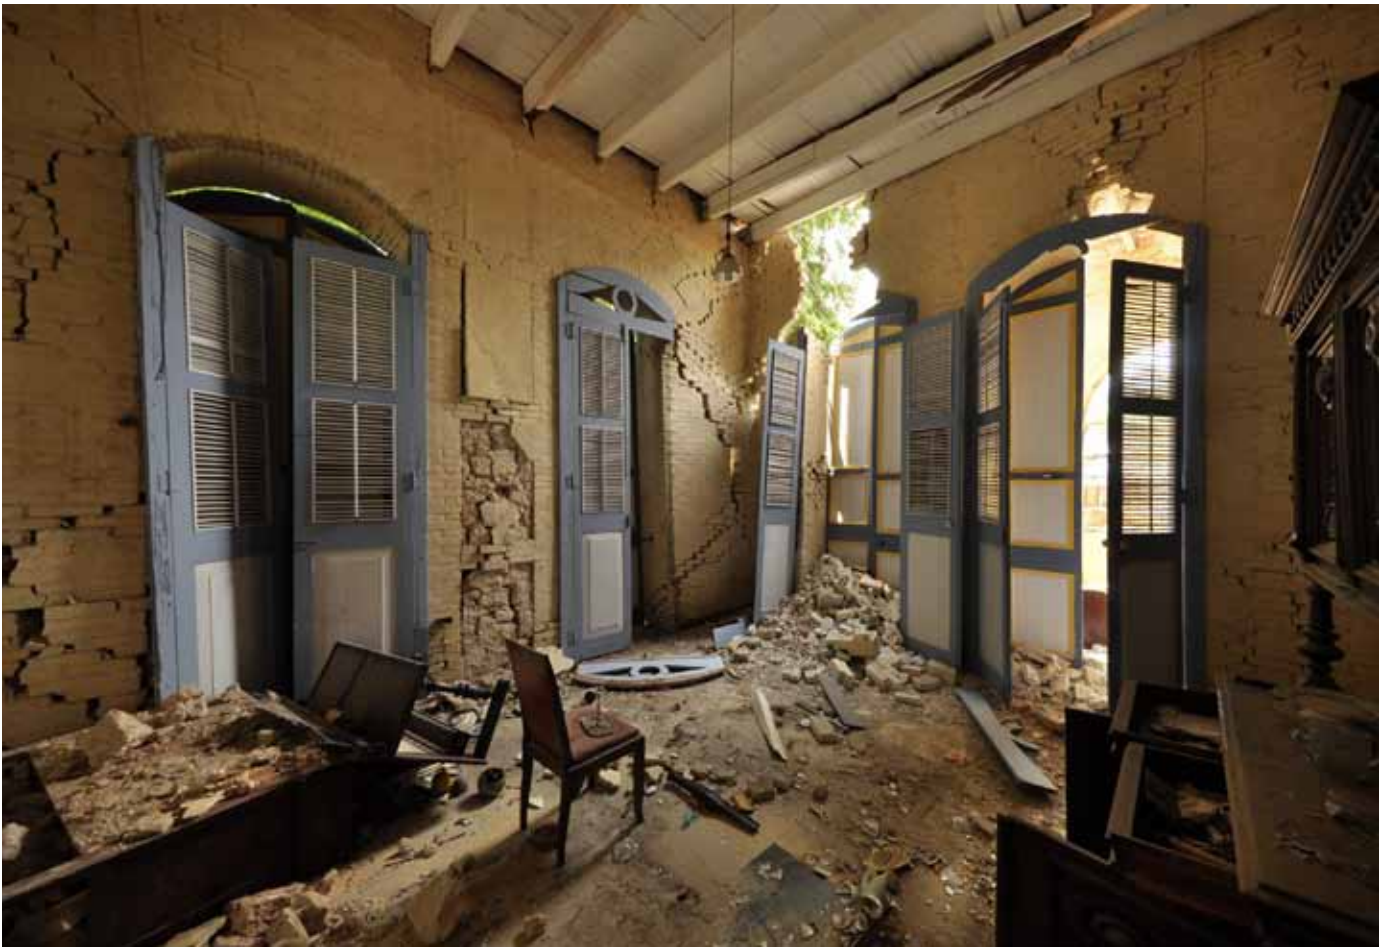
FIGURE 97 Two-story masonry house at 46 Avenue Christophe. During the earthquake, part of the second floor collapsed, followed by the subsequent collapse of the rest of the second floor. These photos show the ground floor, which remained standing, but with major rupture to the masonry walls, particularly at the corners. Right, the iron rod that had held the building together at the floor level is visible where it had failed because of corrosion. This image also reveals how the inner wythe of brickwork was not bonded to the outer layers of rubble stone. To form the inner corner of the room there is a layer of brick, whereas in the middle of the room, the rubble stone panel goes through the entire thickness of the wall.

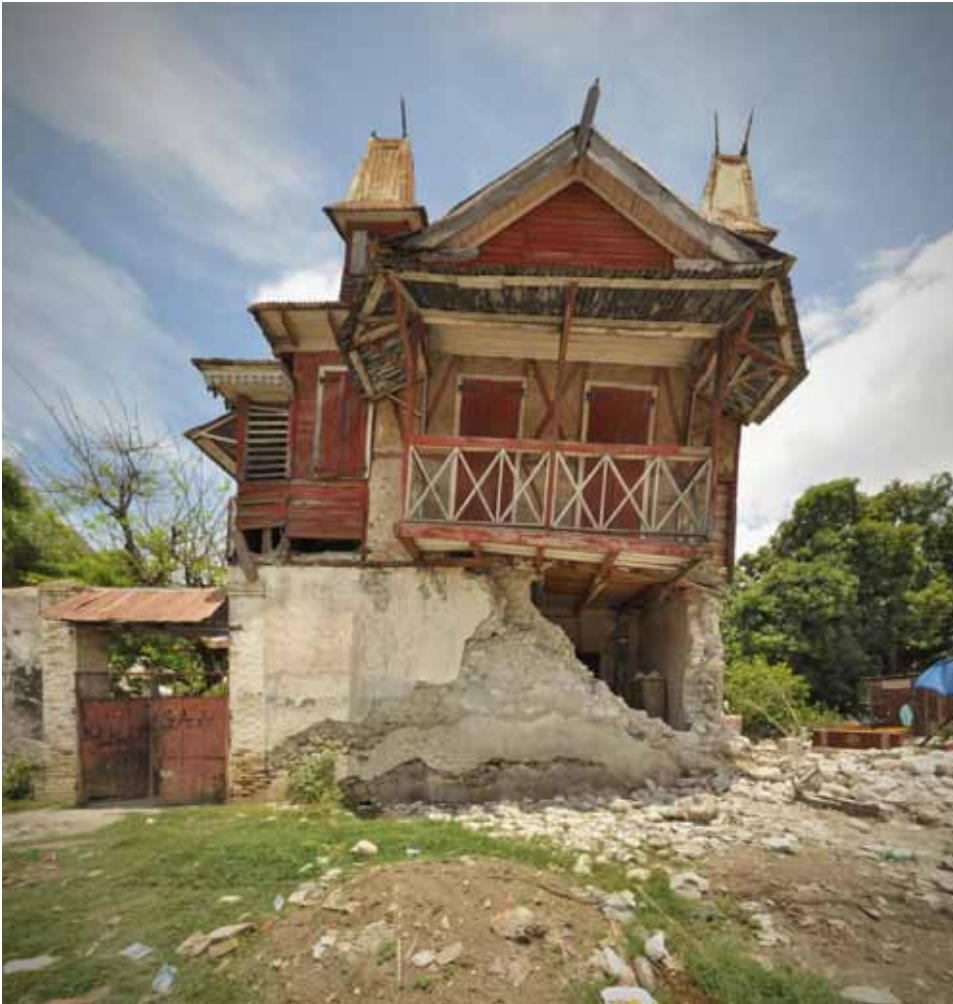
FIGURE 98 House in Léogâne where the solid rubble stone wall on one side partially collapsed, while the side with the two door openings with brick piers and rubble panels seen through the collapse remained standing with much less damage.

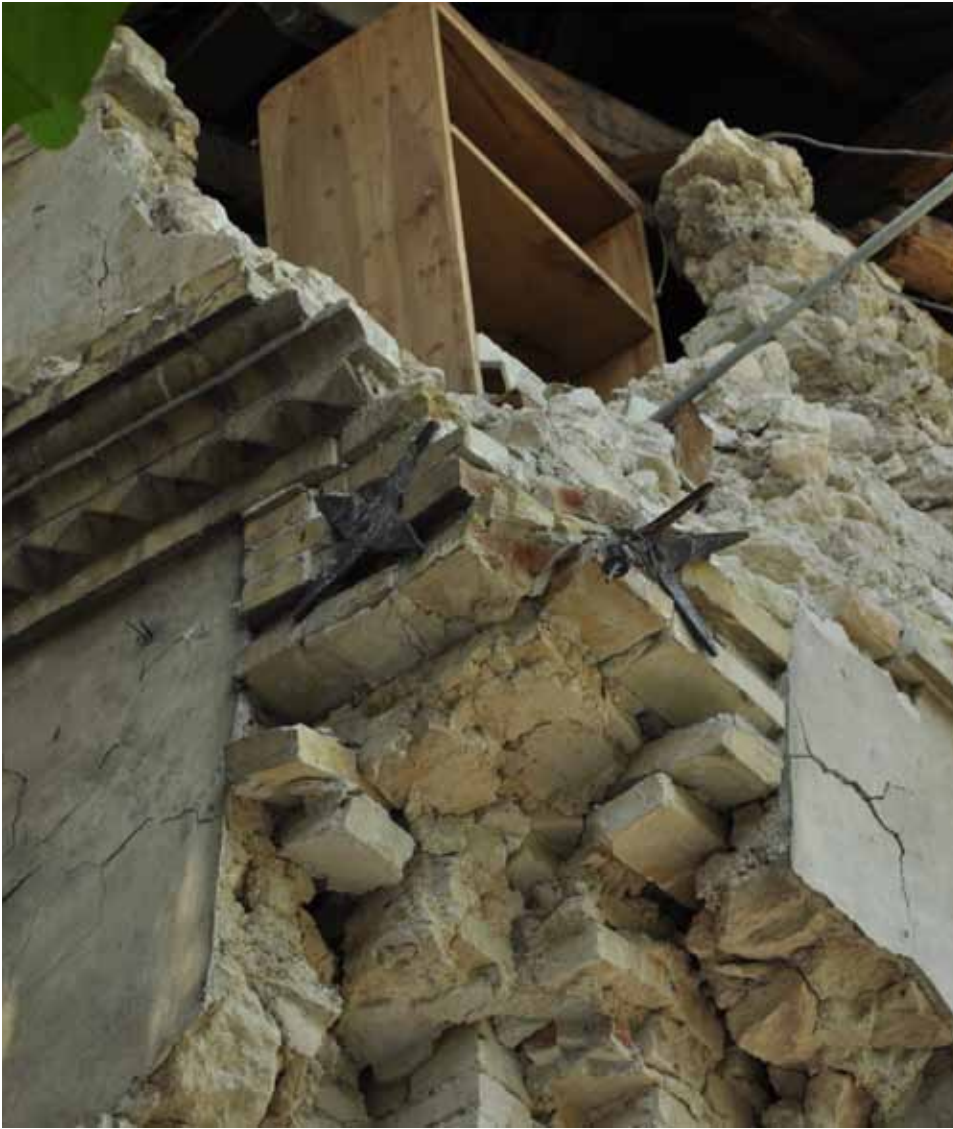
FIGURE 101: Iron chains are common in many of the masonry walls of the Port-au-Prince Gingerbread houses. Above is the first section of the chain with the star-shaped metal plate, and the view at left shows the metal plates where they remain holding the wall at the floor level in place, thus stopping the further separation of the walls at the corner. Had these floor level reinforcement rings not been installed, the lower floor walls would probably have collapsed as well.

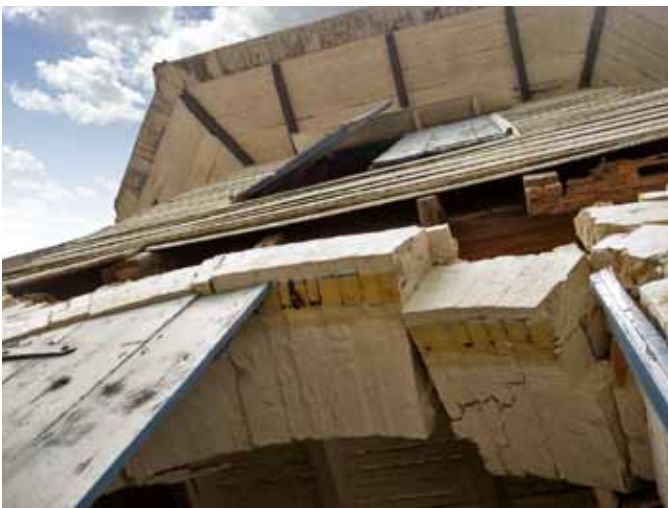
FIGURE 105 Severely damaged arch, and displaced wood framing above. Absence of tie rods, combined with decay of the timber sill plates made the building more vulnerable.

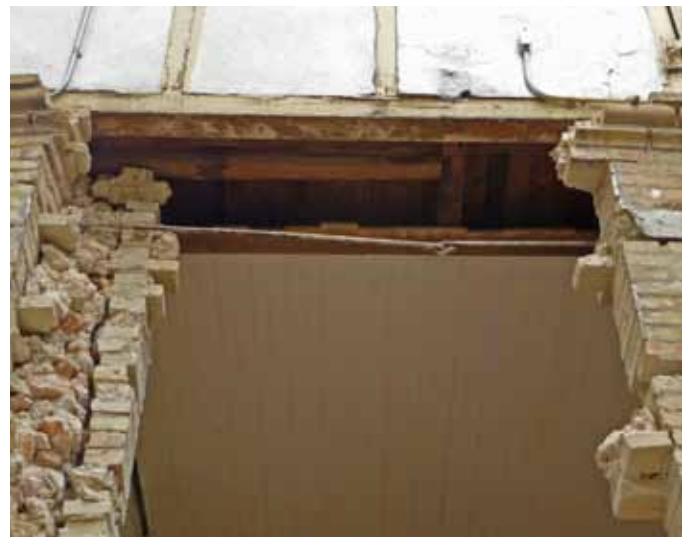
FIGURE 106 Linked iron tension rods exposed after the limestone infill panel was discharged. The rod may have prevented complete wall collapse.

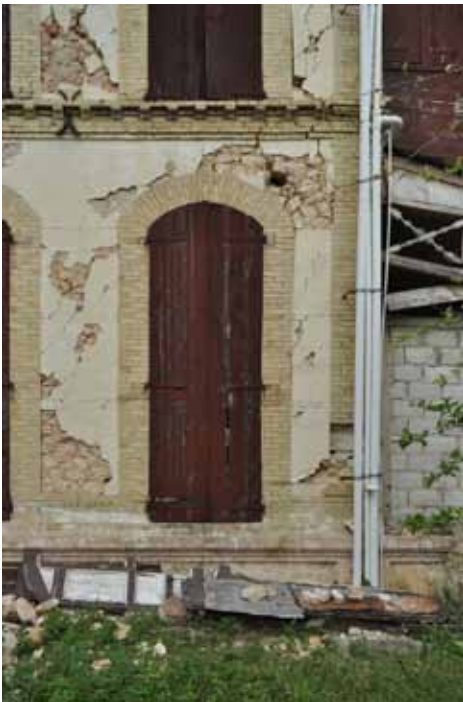
FIGURE 108: The Villa Castel Fleuri shows the effect of the absence of iron chains at the 2nd floor level corners. The pier on the right has been slightly displaced to the right at the second floor level. It is possible to repair it without rebuilding it, but the deflection will then remain visible. A better quality and more resilient restoration will require shoring and relaying of the masonry of the corners of the building with new masonry units to replace the rubble stone. The rebuilt masonry need only extend across to about the middle of the arch.

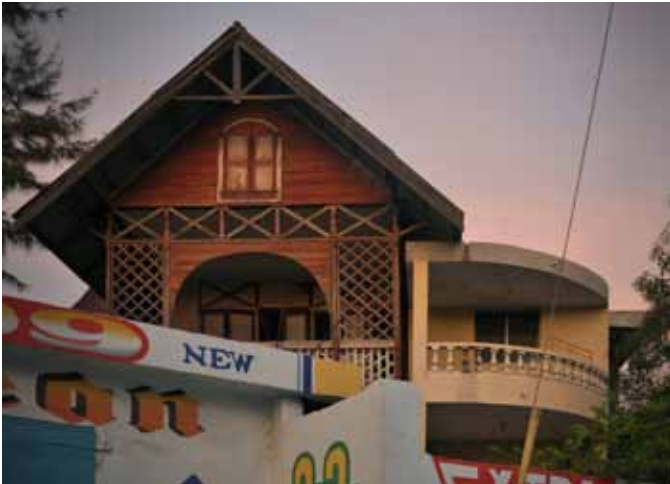
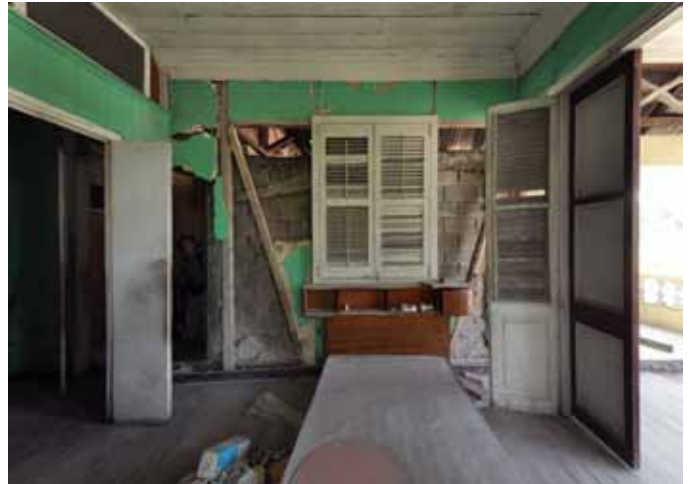
FIGURE 109 Interior and exterior of 51 Avenue Christophe showing reinforced concrete addition to the timber and *colombage* house. The two parts pulled away from each other during the earthquake.

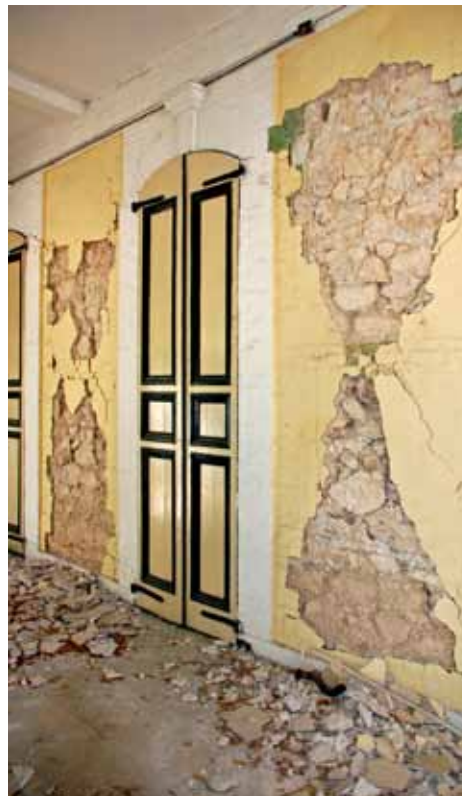
FIGURE 115 The characteristic X-cracks seen on masonry wall infills of concrete frames are also present at Le Manoir. These are due to the reinforced concrete second floor slab (above the damaged wall in this picture).

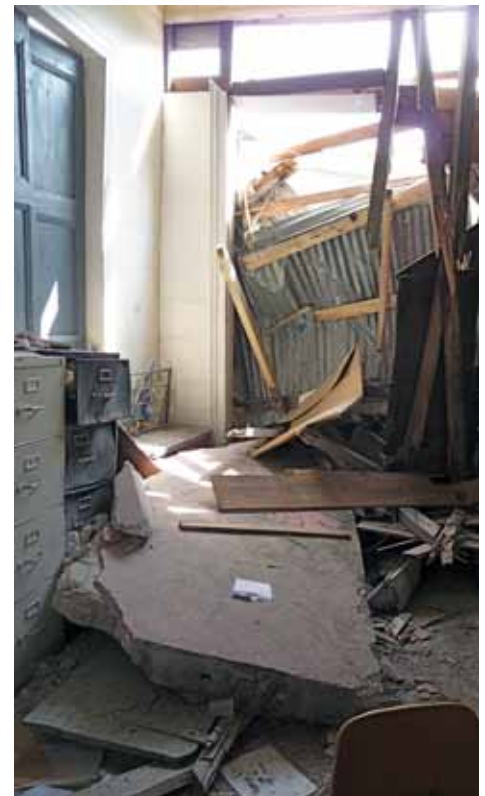
FIGURE 116 The most damage this building suffered was from a concrete slab ejected through its back door from the collapsed concrete building behind.

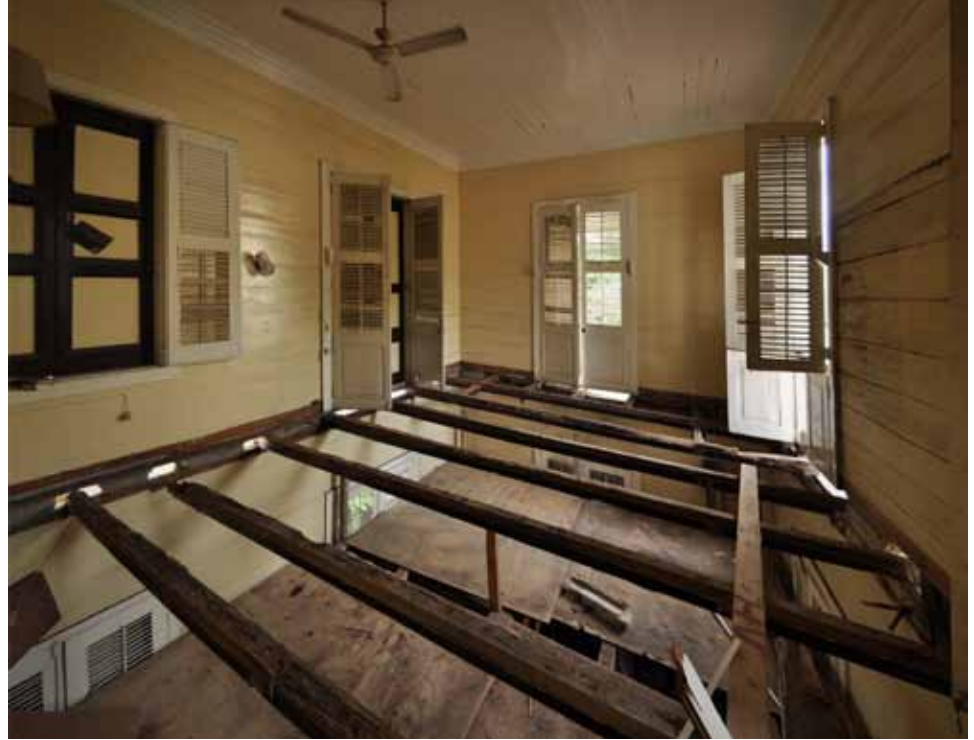
FIGURE 124 House at 32 Avenue Lamartiniere now under restoration, showing the decayed ends of the joists.

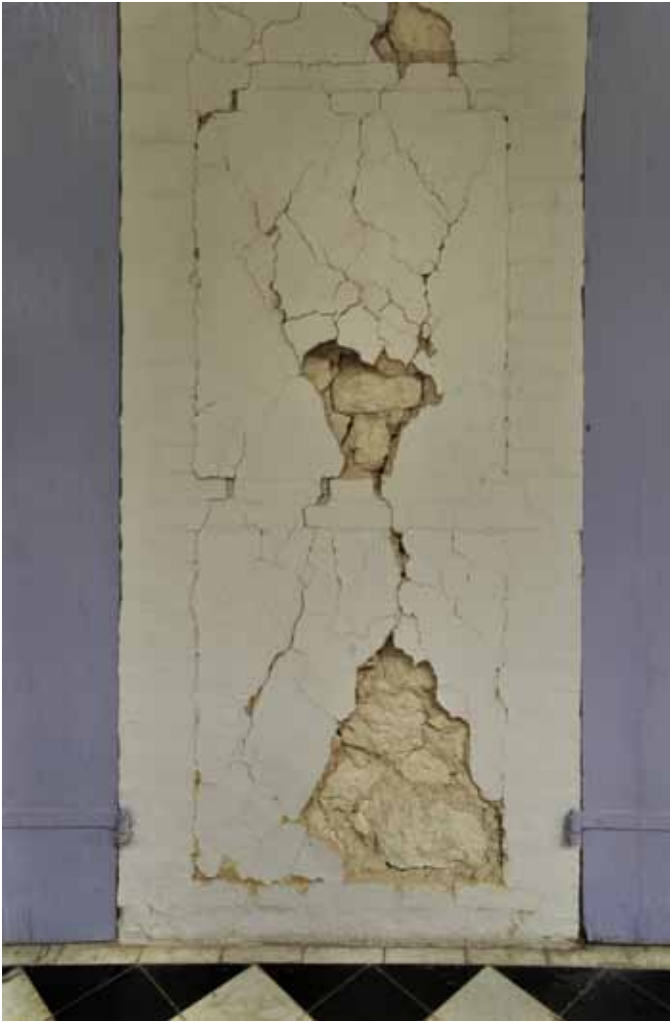
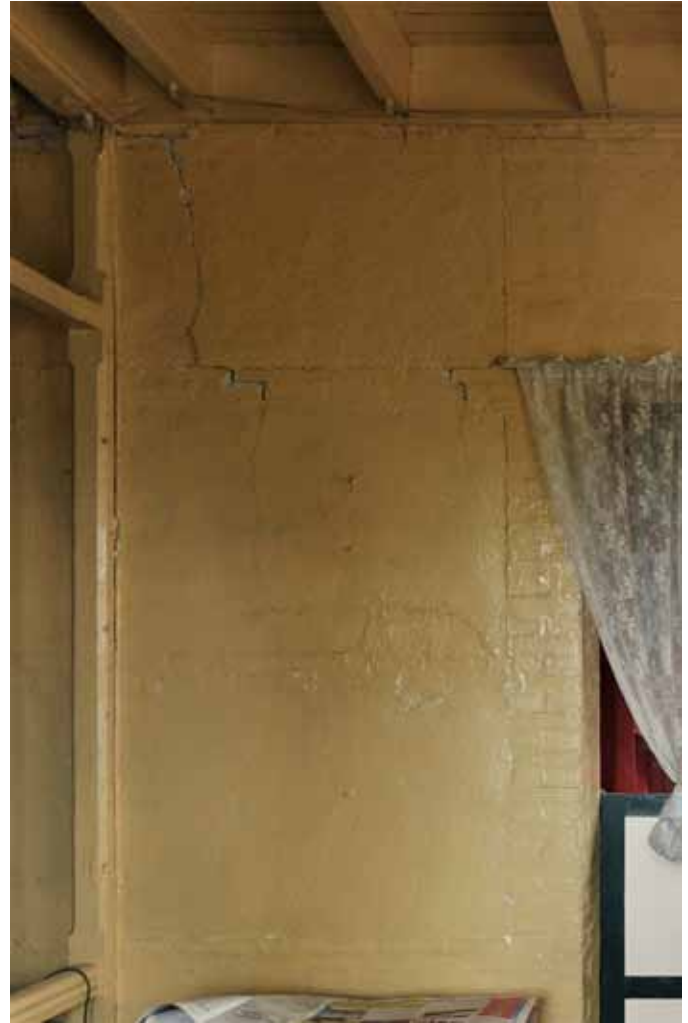
FIGURE 128 Interior and exterior examples of low levels of damage to rubble stone panels in masonry walls.

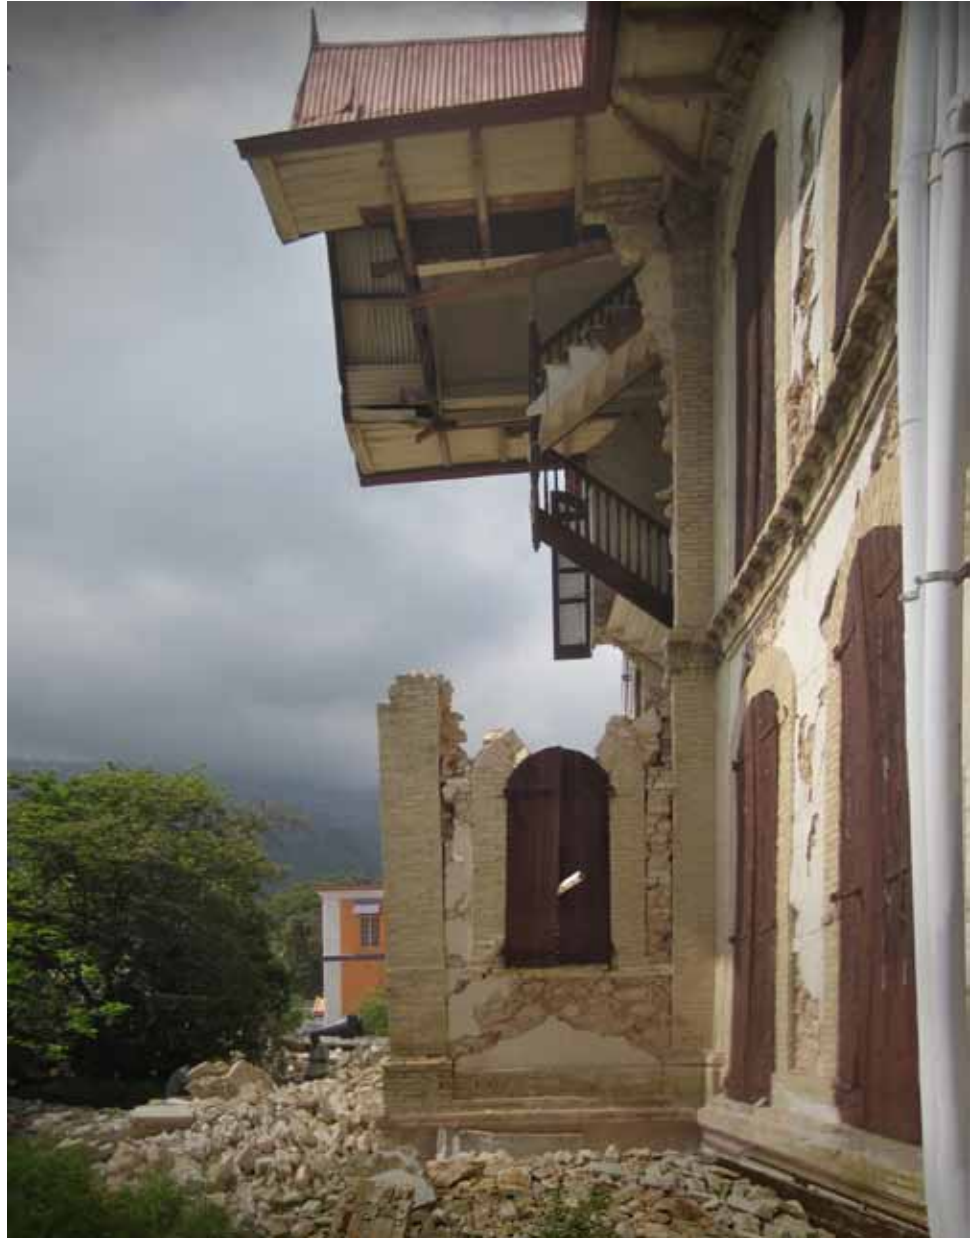
FIGURE 130 *below left:* Le Manoir on Avenue John Brown showing a heavy level of disruption of the masonry walls caused by the rapid degradation of the rubble stone panels during the earthquake. *below right:* A rubble panel on the second floor of the Villa Castel Fleuri that collapsed showing the displacement of the bottom of the brick pier into the doorway which resulted from the expansion forces from the panel.

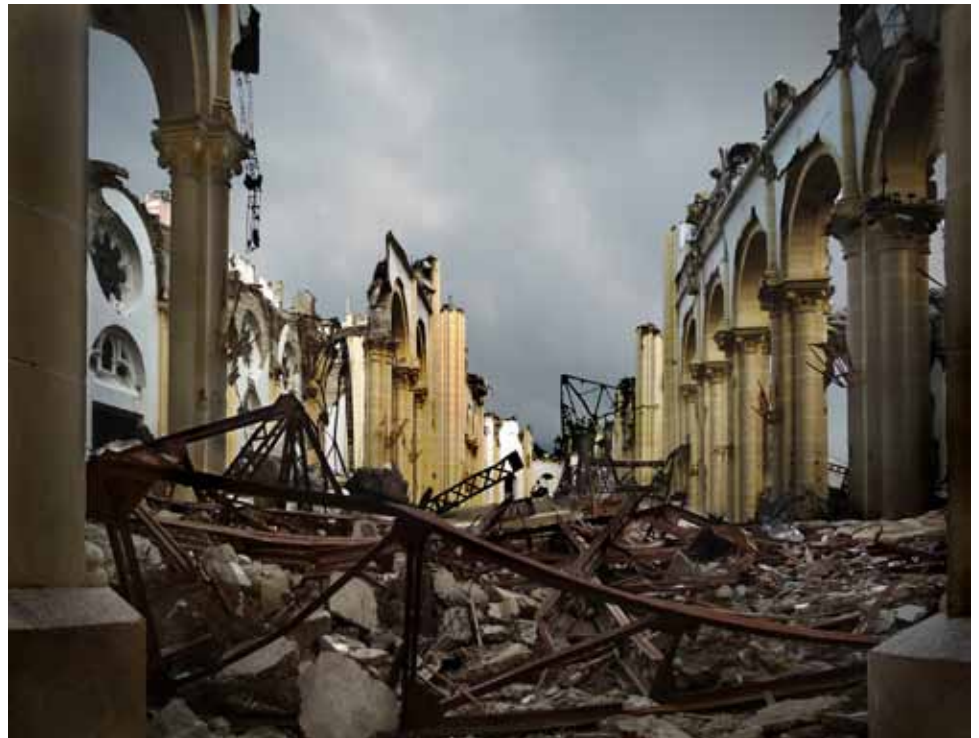
FIGURE 131: interior of the *Cathédrale Notre Dame de L'Assomption* after the 2010 earthquake collapsed much of its walls, almost all of its roof, and the tops of both towers. The building was constructed between 1884 and 1914, with walls of reinforced concrete with infill masonry construction. Much of the reinforcing had become heavily corroded by the time of the earthquake.
