# The Significance Assessment of 204-210 West, 122nd Street

Shuya Zhao, sz3005 Dec. 2021 Shuya Zhao sz3005 Studio 1\_Significance Assessment Faculty: Andrew Dolkart, Claudia Kavenagh, and Kate Reggev Teaching Assistants: Preme Chaiyatham and Jesse Kling

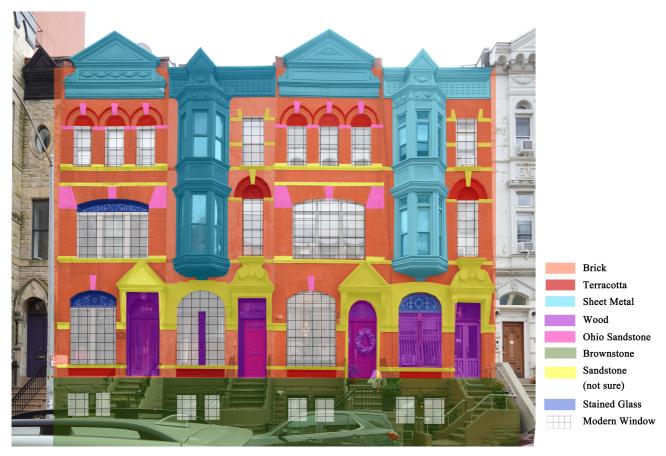
Figure 1. Material

The houses have many different materials on the facade.(Figure 1) They have brick walls, sheet metal cornices and bay windows, wood door and windows, Ohio sandstone trim, brownstone basements, terracotta decoration and stained-glass windows. The paint on one building (206W) has been almost removed, leaving remnants of the coating. Other buildings are well painted recently and appear to be in good condition.

and Ohio Stone".<sup>6</sup> It's not sure whether the painted trims on 206 and 210 West are Ohio sandstone, but they look like sandstone.

Brownstone is used on the basement, stairs, and pediment. The areas of peeling paint of 204's basement clearly show the texture of brownstone. Because the houses are all well painted, it's not clear if all the basement or stairs are made of brownstone.

The stone of the 208's pediment under the paint looks like brownstone, while the light colored stone of 204's pediment seems to be bluestone.

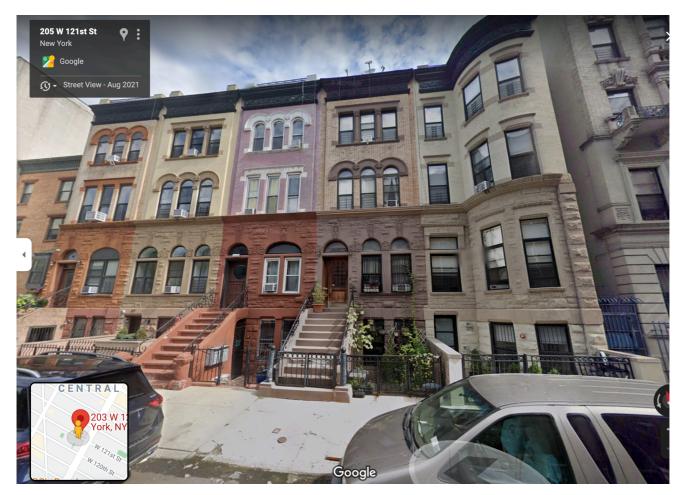
Figure 2. 205-209 West, 122nd Street

The trim of 204 and 208 West are probably Ohio sandstone, because they seem to be the same stone with the ones on 207 West, 122nd Street. (Figure 2) An 1886 article in the *Real Estate Record and Builder's Guide* described it as "the upper stories with Philadelphia pressed brick

The row houses at 205-209 West 122nd Street were listed as a model row in the article in the *Real Estate Record and Builder's Guide* in 1886, saying that they are striking in the contrasts of color and in all respects.<sup>7</sup> The study houses are more contrasting, in the material, color, and style. A book about the row houses in New York said that 1873-1893 was "the Eclectic Decades".<sup>8</sup> A variety of styles appeared in the two decades following the Panic of 1873, including Neo-Grec, Queen Anne, and Romanesque Revival.<sup>9</sup> The variations were welcomed even in one row of houses. There are many examples, one of which is the houses at 10-18 Arlington Place, Bedford-Stuyvesant, Brooklyn, which were also built in 1886. (Figure 4)

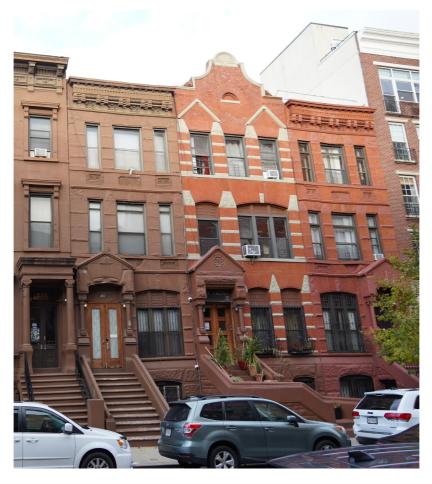
Figure 3. 203-211 West 121st Street

As mentioned before, the row houses opposite to and behind the study building were designed by the same architect. The three houses located at 205-209 West 122nd Street were built in 1885. The five houses located at 203-211 West 121st Street were built in 1888.(Figure 3) They use some of the same materials, such as brownstone, Ohio sandstone, and have several similar window types, such as the double-hung sash window and the window with curved transom. However, the buildings have different cornices. 205 and 209 West 122nd Street have terracotta cornices, while those at 203-211 West 121st Street have sheet-metal cornices without pediments. Houses at 203-211 West 121st Street don't have projecting porches. Although the study houses of 204-210 West 122nd Street are a little smaller in terms of length and depth,

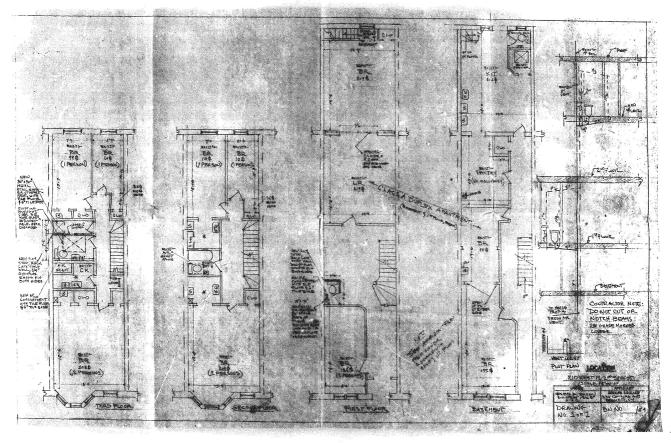
Figure 5. 1970s plan of 210 West, 122<sup>nd</sup> Street

In terms of floor plan, except for the basement, all of the study houses have 4 floors.<sup>10</sup> (Figure 5) Now 210 West 122nd Street has been used as an Airbnb hotel and others are residential houses. The owner of 210 West 122nd Street hotel added a kitchen on the first floor, and made some changes to the bathroom, to make sure that every bedroom has its own bathroom.<sup>11</sup> (Figure 6)
