Preserving Haiti's Gingerbread Houses

2010 Earthquake Mission Report

A World Monuments Fund / ICOMOS Project funded in part by Prince Claus Fund and FOKAL

**2010 Earthquake Mission Report
December 2010**

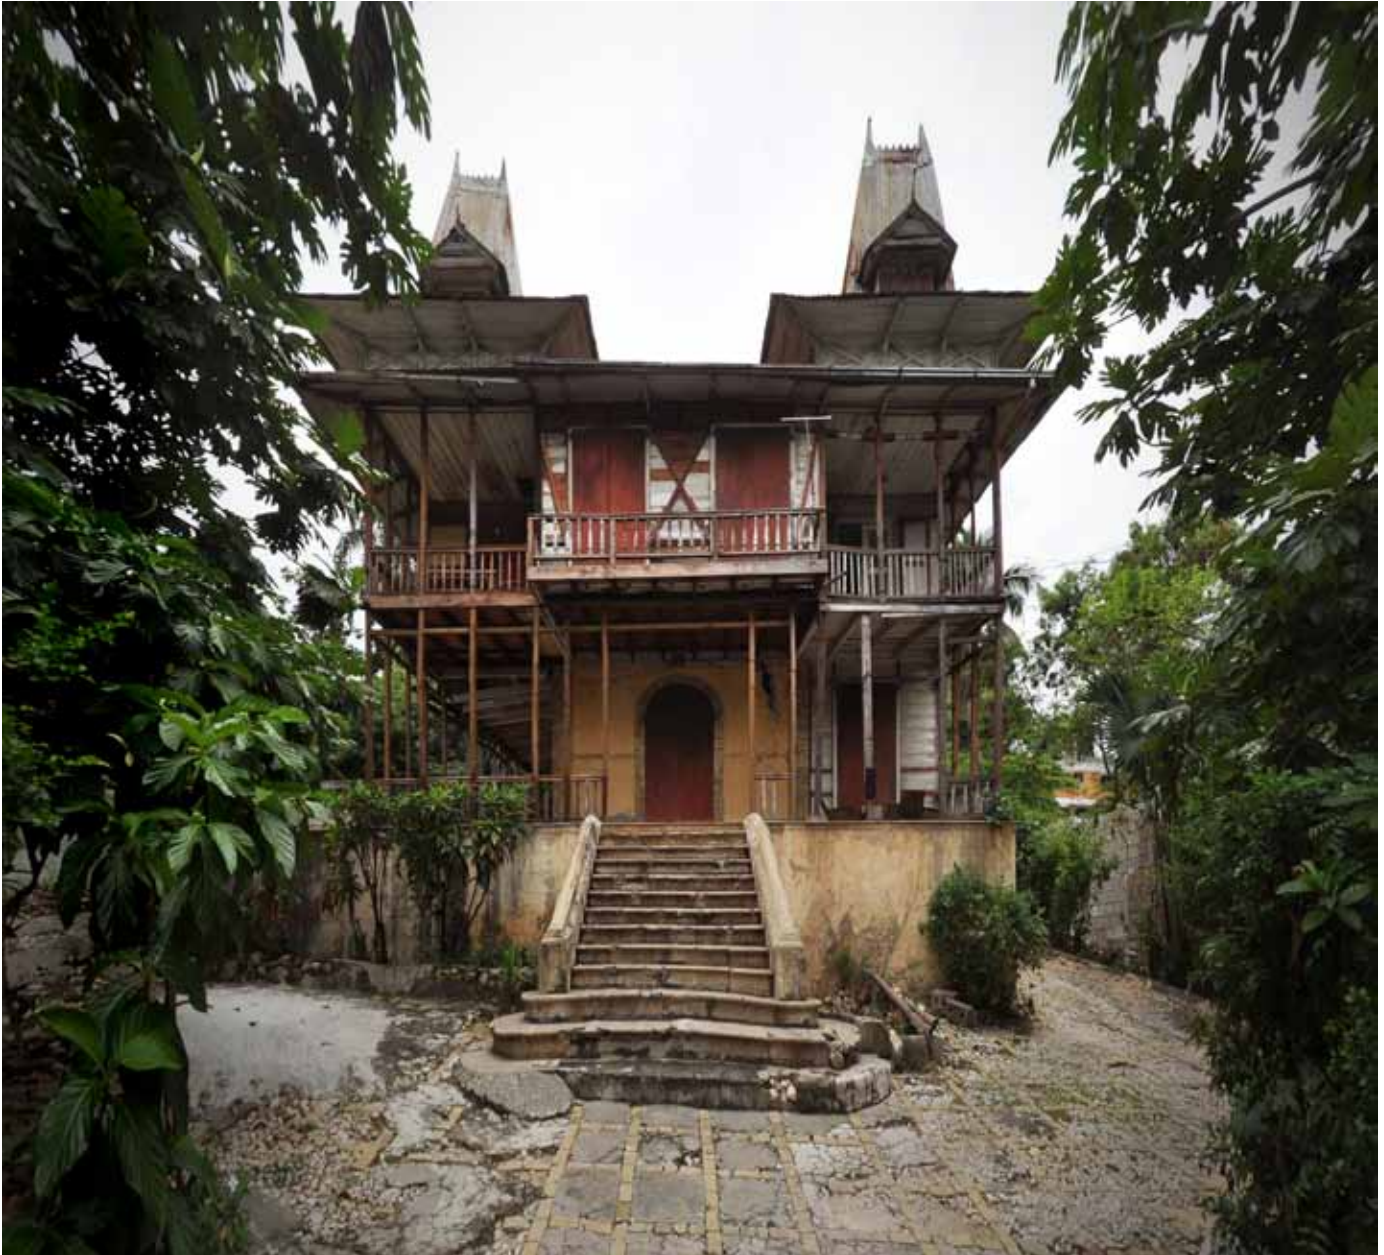
FIGURE 2 above: The Patrice Pamphile House at 4 Rue Casseus, a particularly unusual yet characteristic house in the Haitian vernacular of the Gingerbread era. It combines stone and brick masonry construction with *colombage* and timber frame and clad sections into one composition. The wide porches, tall doors and high ceilings are all characteristic elements of the Gingerbread typology.

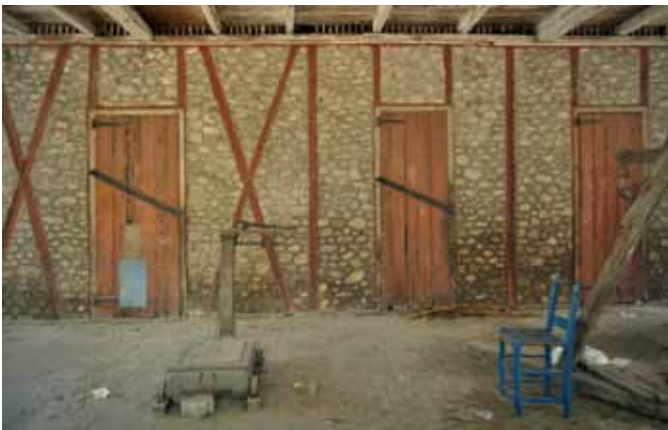
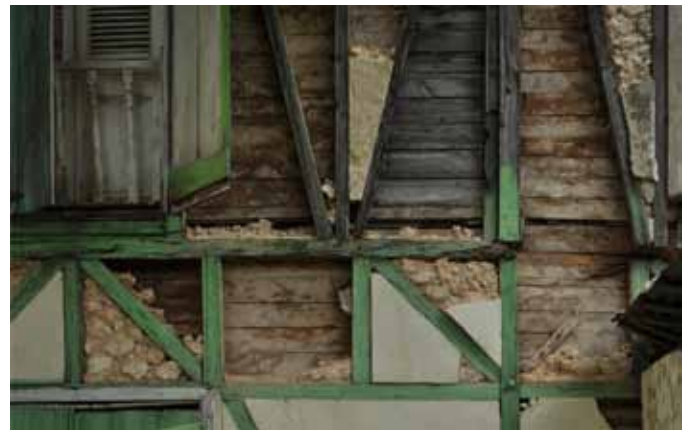
FIGURE 25 *left:* A barn in Léogâne is an example of rubble stone *colombage* made with stronger igneous rocks than those used in Port-au-Prince, and not stuccoed. *right:* A heavily damaged *colombage* wall showing the rubble stone infill characteristic of Port-au-Prince.

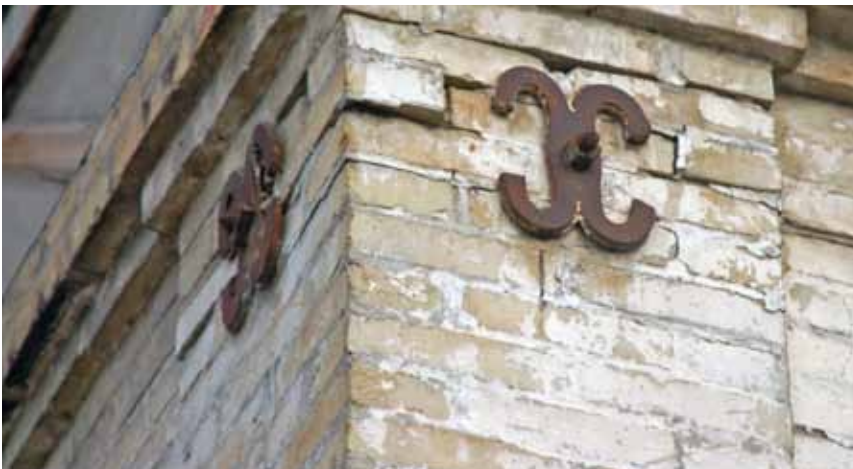
FIGURE 26 View of decorative end plates at the corner of this brick structure indicate horizontal ties along each wall of the intersect.

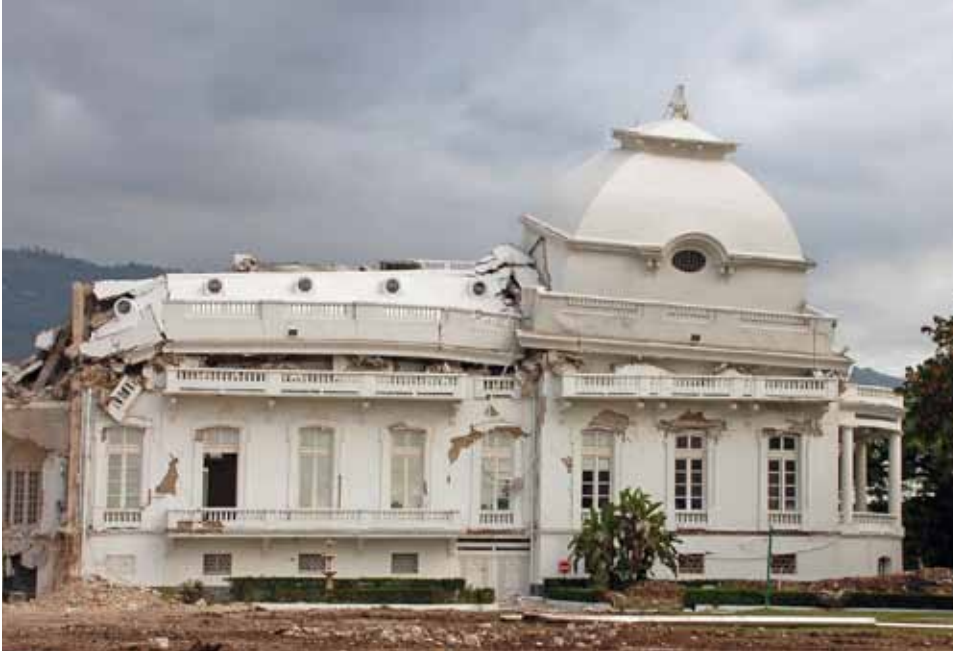
FIGURE 28 The *Palais Nationale*, constructed in 1918, is an example of early reinforced concrete use in Haiti. These buildings typically collapsed.

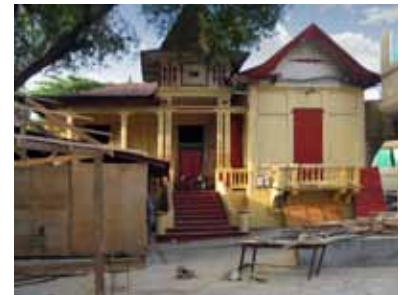
FIGURE 30 Concrete frame/confined masonry Gingerbread. This is the only variant of this type seen. It was undamaged.

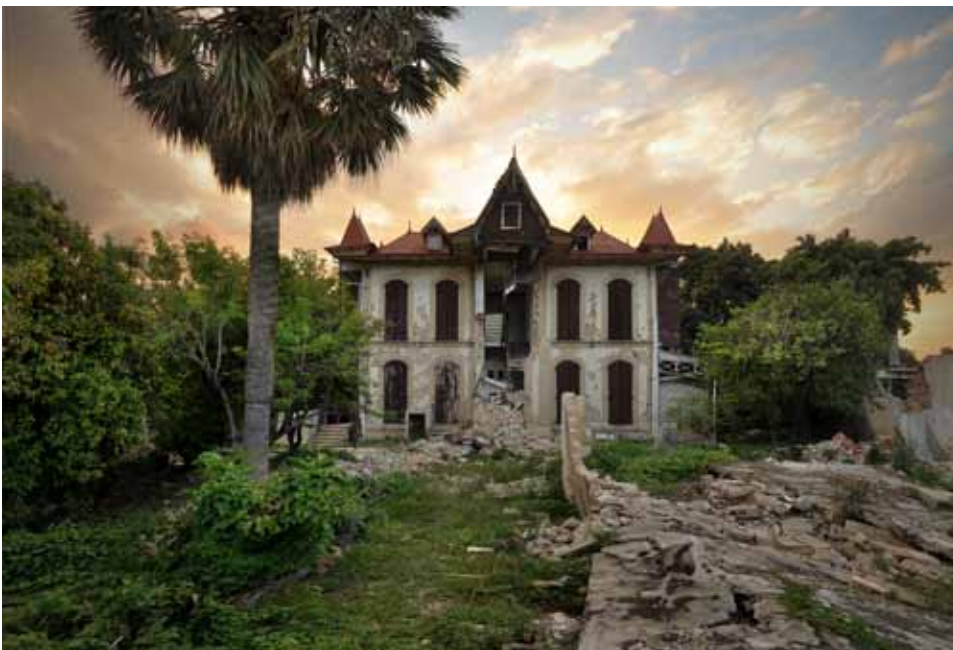
FIGURE 29 The east front of the Villa Castel Fleuri on Avenue Christophe, a grand brick and rubble stone masonry house. This house was occupied by the President of Haiti for a short period in its history. It has suffered extensive damage in the earthquake mainly to the projecting stair tower on the east side, and porches on the west. The plates that hold the iron ties that penetrate the building are visible on the façade.

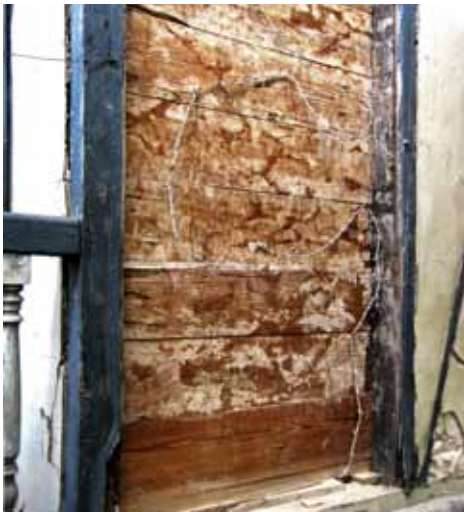
Where rubble stone infill is used, it is often reinforced with barbed wire laid haphazardly within the space to be filled, and nail fastened to the wood members on both sides of that space (Figures 40 and 41). In many cases, horizontal sheathing was nailed to the inside of the frames, then the earthen mortar and stones were placed between the wall framing members. Nails were used at roughly six-inch intervals in most buildings to help hold the infill (Figure 43).

FIGURE 40 In this *colombage* construction the stone infill has collapsed due to the earthquake revealing the barbed wire reinforcement. This is an example of a non construction material being adapted for construction due to its apparent availability. The barbed wire was galvanized and is still in good condition.

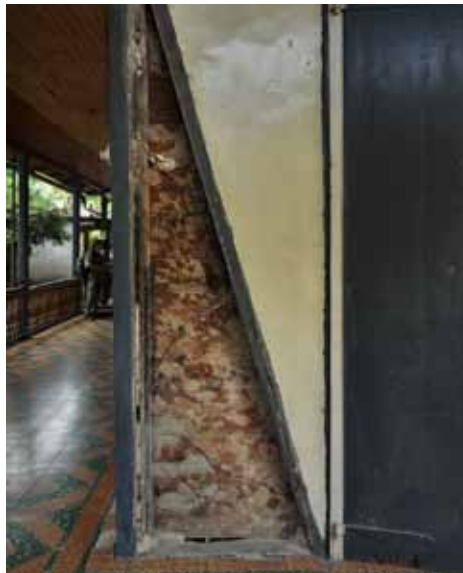
FIGURE 41 House at 15 Rue M showing plastered rubble stone infilling. On the left, one panel fell out in the earthquake, revealing that it was reinforced with barbed wire inserted into the bay in a zigzag layout.

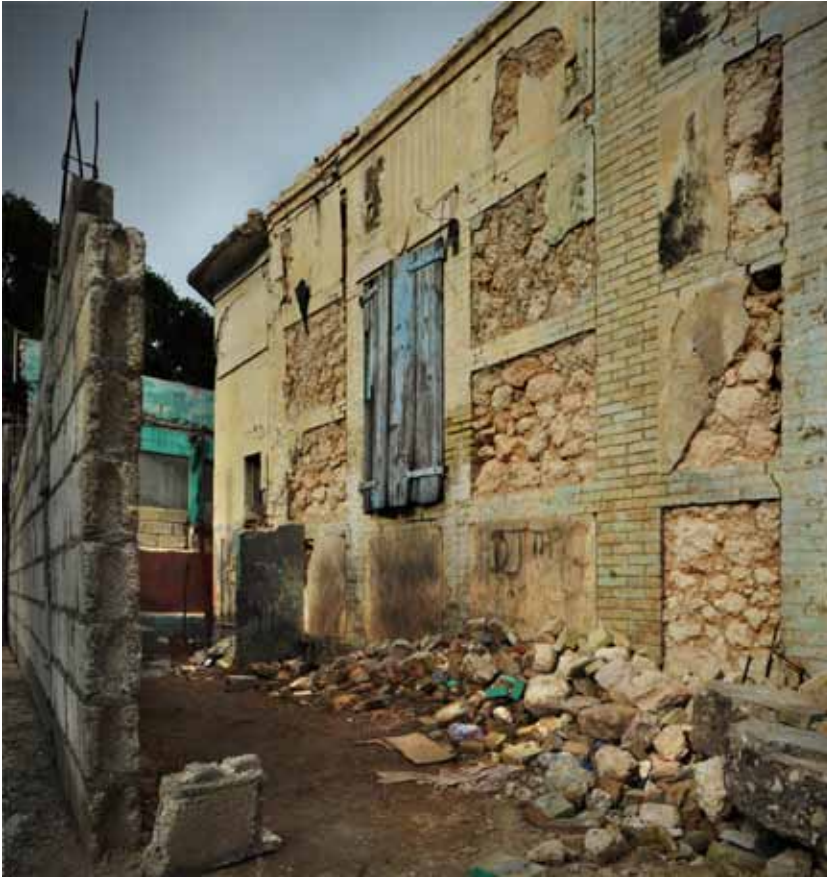
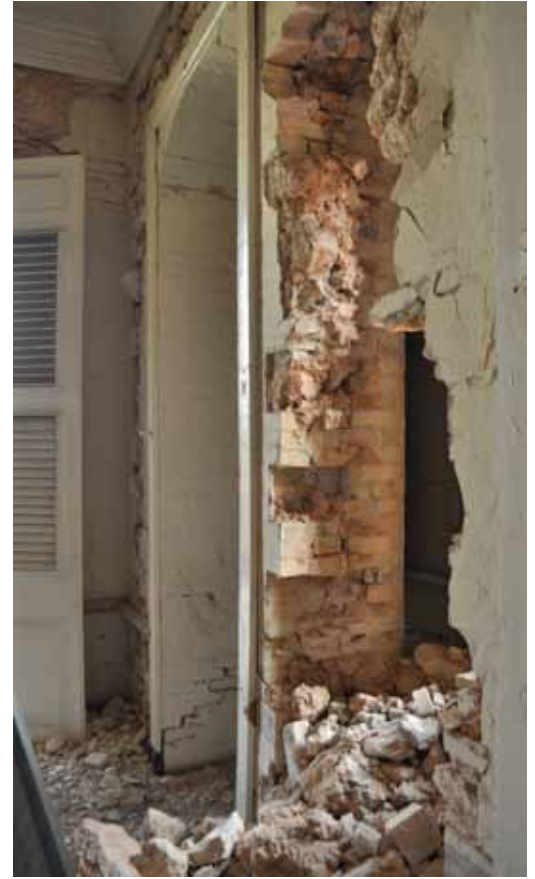
FIGURE 45 *left:* Wall of a commercial building on Avenue Lemartiniere showing the characteristic layout of the mixed brick with rubble stone masonry found in many Gingerbread houses in Port-au-Prince. The brick piers and horizontal brick courses are crucial in restraining the walls from complete collapse. *right:* Interior view of wall of the Villa Castel Fleuri (see Figure 1) showing a rubble stone panel which has completely collapsed out from between the brick masonry piers. Notice the brick keys that had extended into the rubble stone panel.

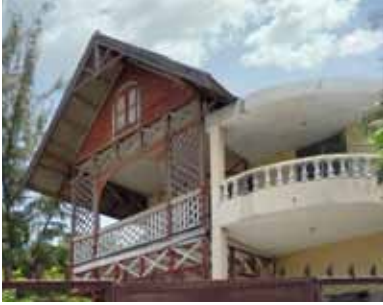
FIGURE 48 Concrete additions are often awkward or compromise the Gingerbread buildings architecturally, like this one at 51 Avenue Christophe.

Additions: Concrete and concrete block additions to the Gingerbread buildings are very common, especially close to the city center (Figure 48). Less common, and older, are additions of unreinforced brick and rubble stone masonry. Occasionally remodels using concrete and concrete block were built to replace a portion of the building that had suffered deterioration or damage, or replacement may have been seen as an upgrade. These additions were often added for new kitchens or bathrooms, and thus were constructed with heavy concrete and tile interiors. When bathrooms were installed at the second-floor level, the additions sometimes were constructed on reinforced concrete legs, and thus their weight under lateral loads was imposed onto the historic house.

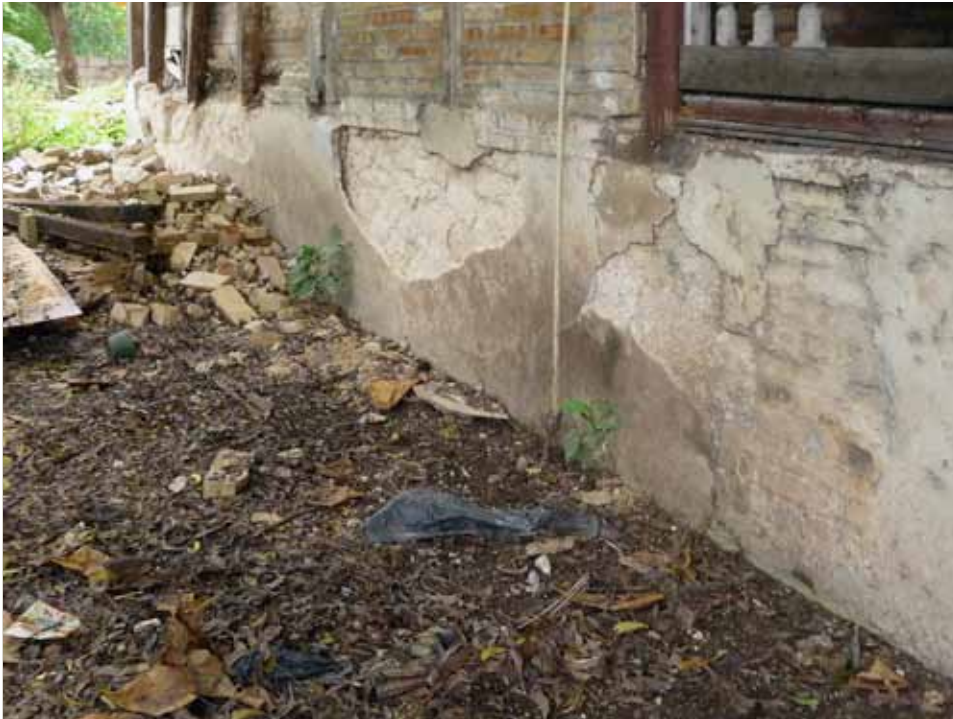
FIGURE 50 Spalling of the exterior finish plaster of the house at 84 Lamartiniere reveals two contiguous sections of foundation stem wall. One of irregular limestone *left*, and one of brick *right*.

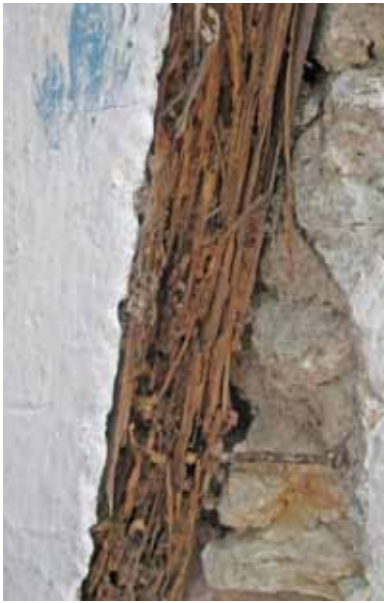
Insect and fungal decay: The principal condition that was seen in the structures composed of wood was the evidence of termites (Figure 62). Termite damage and, to a much lesser extent, wood rot were commonly observed in *colombage* and timber frame buildings and appeared to play a role in the extent of earthquake damage suffered, especially where decay affects the tie between floor and wall, or wall-to-wall at a corner (Figure 63). For example, severely rotted or termite-damaged bottom plates sometimes failed and allowed entire masonry panels to fall out under their own weight (Figure 64). Wood elements directly exposed to weather or to leaks in the building envelope were subject to rot (Figure 65). This is especially true at locations that invite rainwater collection (bottom plates, 'V'-shaped diagonal-to-vertical joints, bottoms of porch posts) and at locations in poor drying environments (areas of constant shade and/or limited air movement).

FIGURE 62 Termites thrive in Port-au-Prince, and many of the wooden structures are severely damaged due to termite attack.

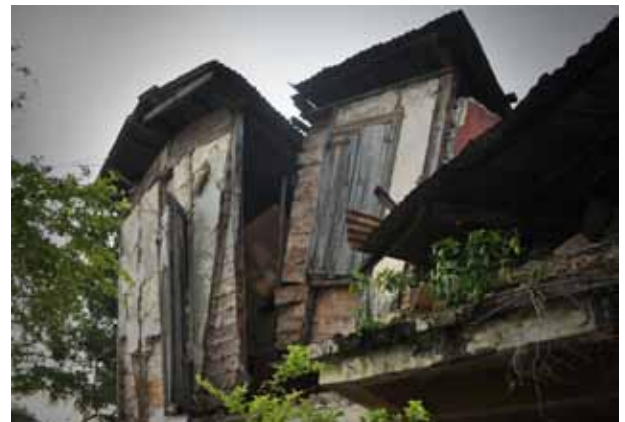
FIGURE 63 Heavily rotted and termite-eaten house on Avenue Lemartiniere, which partially collapsed during the earthquake.

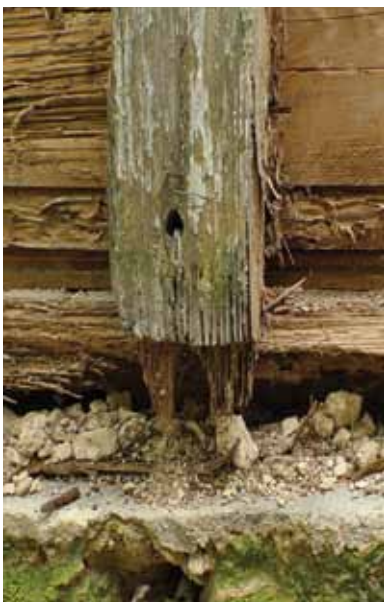
FIGURE 64 The post tenon is still present; the sill has rotted away.

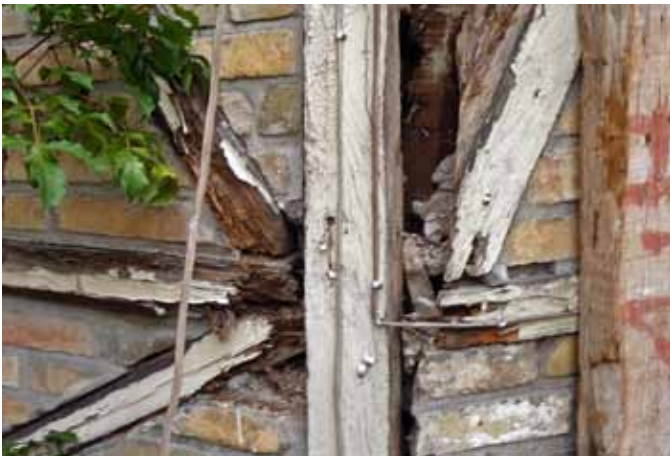
FIGURE 67 Rot of timber frame members at corner of *colombage* house at 32 Lamartiniere.

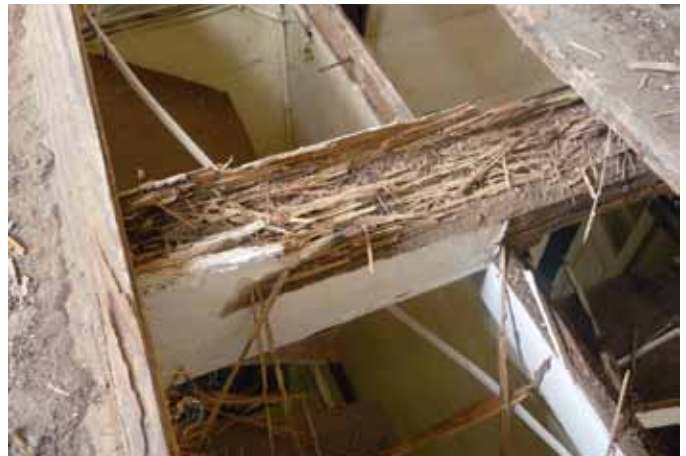
FIGURE 68 Termite damage in second story floor joists.

Termites are extremely aggressive in Haiti and have left numerous balconies and floor boards in an unsafe state (Figure 66). Termite damage was most often seen in the following structural elements: timber framing in *colombage* walls and in wood frame walls, floor planking (first and second floor), floor joists, and porch posts (Figures 67 and 68). Wood members within *colombage* construction, and within frame construction with pocket walls, allow termites to propagate undetected to the upper floors through timbers that are set in masonry or which are clad on both the inside and outside.

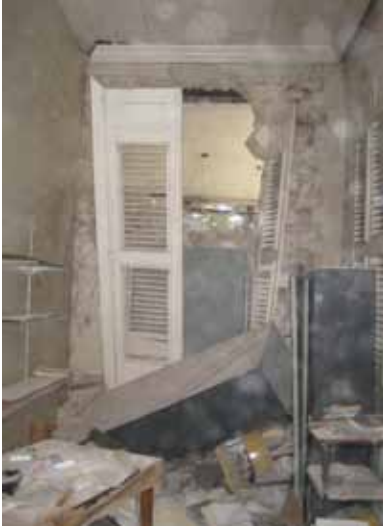
FIGURE 69 Hole in the masonry wall of Castel Fleuri caused by a concrete vault constructed in the exterior side and adjacent to this wall.

Concrete Additions: The first was the widespread use of reinforced concrete and/or concrete block to build additions to the Gingerbread Houses. These additions become a structural concern during seismic loading (Figure 69). Houses constructed of braced timber frame or *colombage* have a relative deformability compared to concrete, so during an earthquake the original structure and concrete addition act as separate structures and strike each other. This typically led to damage of the Gingerbread house where it interfaced the addition, and also led in some cases to collapse of the addition (Figure 70).

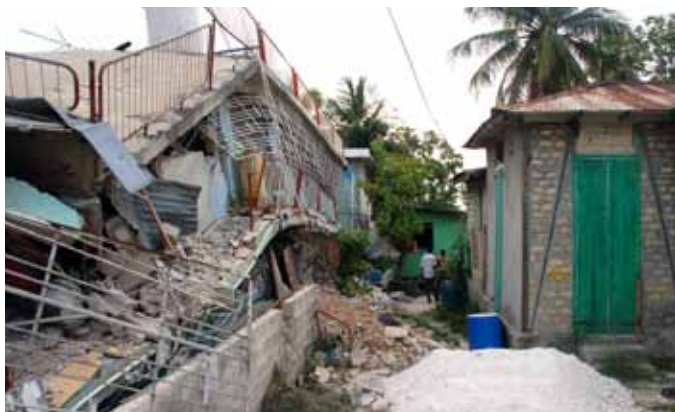
The earthquake performance of the buildings of Port-au-Prince in general can be ranked from best to worst in the following manner: wood structures, masonry structures, and concrete structures. The observations of the mission revealed that this was true of the Gingerbread Houses as well (Figures 75 and 76). Both the braced timber frame and the *colombage*, with their more flexible, energy dissipating systems, tended to perform best (Figure 77).

FIGURE 75 A pancaked concrete-frame building on the right and a *colombage* house on the left showing the comparative performance of these building types in a seismic event.

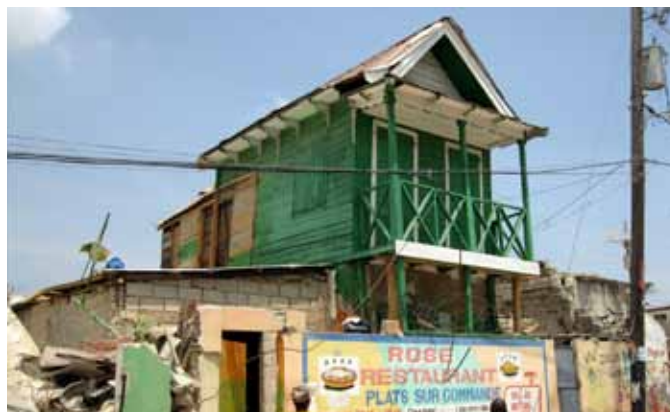
FIGURE 76 This two-story *colombage* house survived amid the collapse of numerous concrete buildings. The owners do not want to tear it down. However, it needs temporary stabilization and long-term repairs.

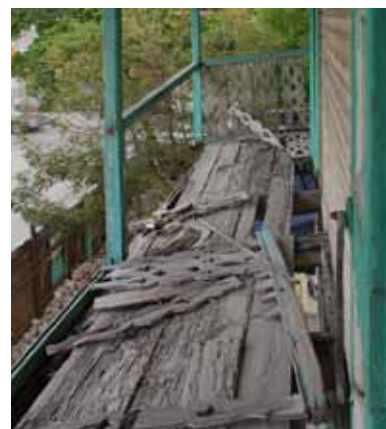
- Collapsed porch structures that had previously been severely compromised by unchecked termite damage (Figure 78).
- crushed sill plates causing the entire structure above to settle lower on its foundations making operation of doors difficult or impossible (Figure 79).
- Collapsed exterior walls especially when they are not load-bearing and therefore not engaged by compression into the structure as a whole.

FIGURE 78 Second-floor porch structure made unsafe by termite damage.

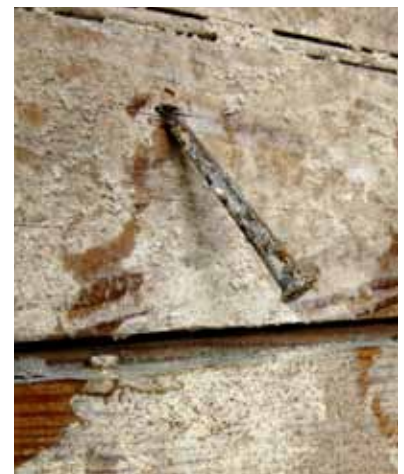
- The forged nails often have not rusted excessively (Figure 81). This could be attributed to the elevated terrain of the Gingerbreads (away from the direct effects of salt), to the prevailing winds being from the east/southeast, and also to the relatively dry climate of the west end of Hispaniola. However, the oxides still tend to cause the nail holes in the wood to widen, weakening the nailed connection. Iron oxide (rust) from bare steel nails can also react with the cellulose in wood, causing the hole to grow in size over time, reducing the friction holding strength of the nail.

FIGURE 81 Cut nails of iron or steel are common in the Gingerbread houses. Many of the original cut nails show surprisingly little corrosion.

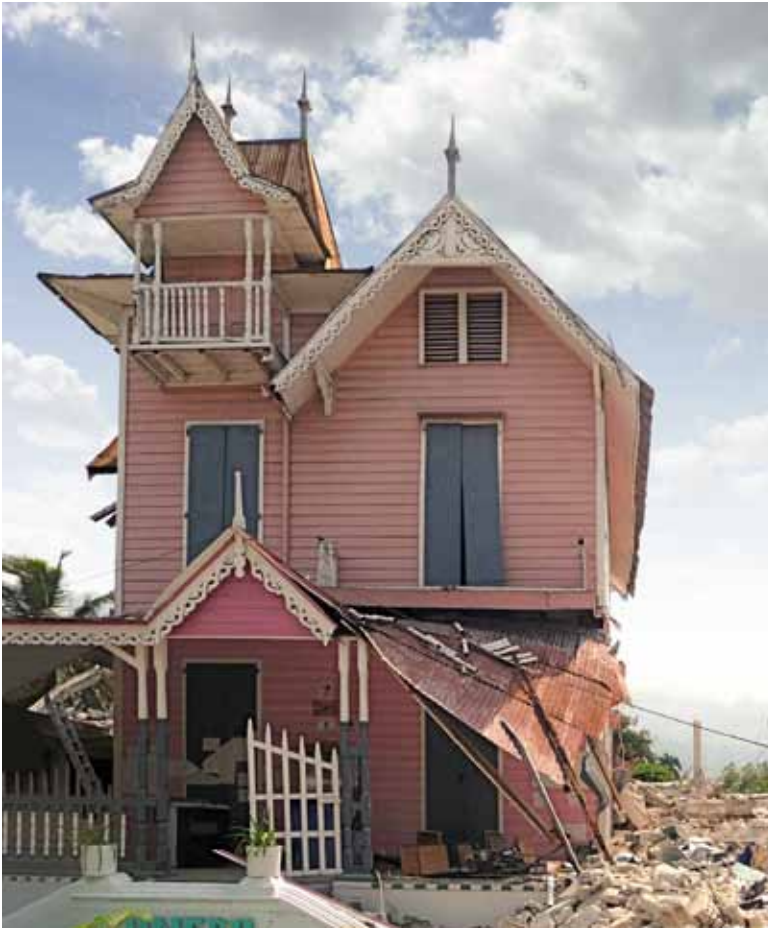
FIGURE 82 Wood frame Gingerbread at the Episcopal University on Rue Capois next to the site of a collapsed concrete building.

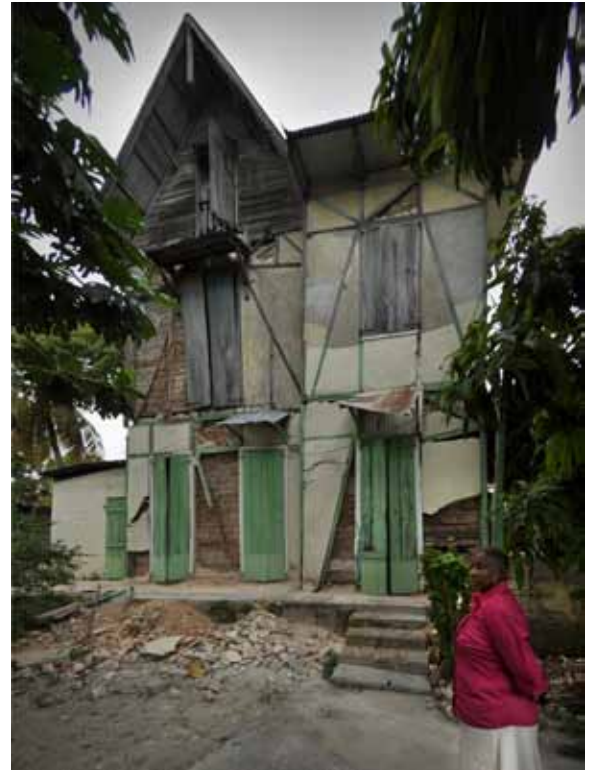
FIGURE 83: Marie Céleste Florence Jacob, seen here, continues to live in this century-old wood frame house at 14 Rue Marcelin. This house was extensively consumed by termites prior to the earthquake which damaged it further. Even in this badly compromised state, this structure remained standing after the earthquake only a few short blocks away from the National Palace and many other concrete frame structures which collapsed.

Some of the buildings inspected were found to have such extensive termite damage that they could reasonably be considered to be beyond repair. Even where this was the case, collapse of these timber frame structures in the earthquake was extremely rare (Figure 83). However, localized damage caused by the earthquake in many of the houses has served to reveal how extensively they had been consumed by the termites (Figure 84).

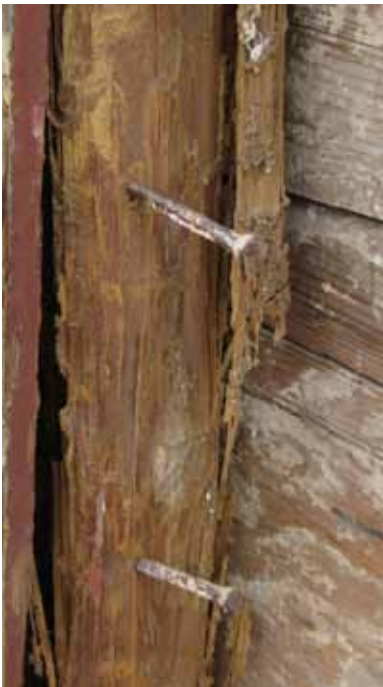
FIGURE 84 Despite extensive termite damage, the remainder of this post is hard and dense, still holding the nail firmly.

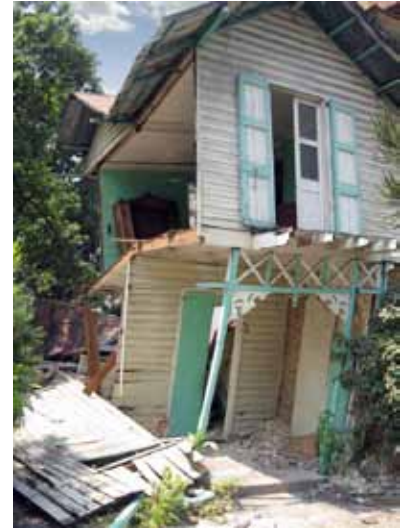
Colombage: *Colombage* construction, which incorporates the braced frame, behaved in a similar fashion to braced frame construction and exhibited similar conditions and pathologies as noted above (Figure 85). With *colombage*, however, the masonry infill panels (of either fired brick or rubble stone) in many cases became loosened or completely fell outward (Figures 86 and 87). This should not be considered a failure of the *colombage* technique as the masonry behaved as an energy absorber and protected the building frame as a whole by absorbing the lateral movements in a sacrificial manner.

FIGURE 85 Despite severe damage, this *colombage* building did not fully collapse. Note that the wall that fell away is the one on the side parallel to the joists, thus not having substantial tie to the floor.

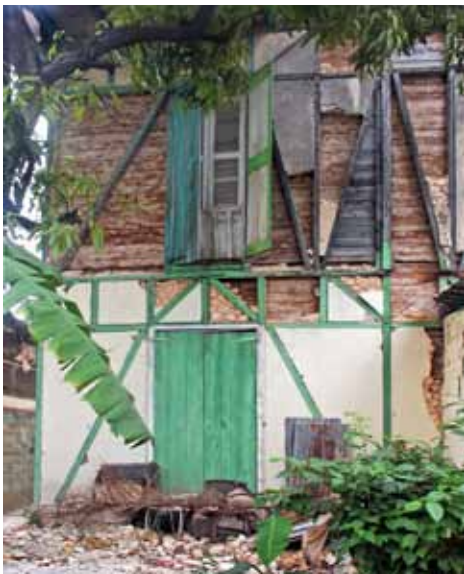
FIGURE 86 Much of the *colombage* stonework fell out of the walls of the second story during the earthquake.

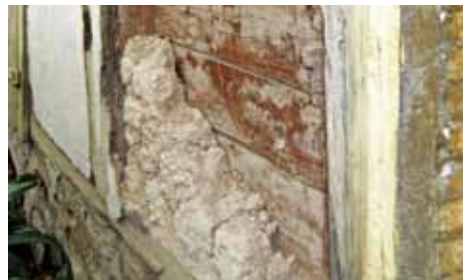
FIGURE 87 Close-up view of the failed *colombage* stonework. This infill, if laid up in clay, crumbles away and does not compromise the integrity of the wood braced frame.

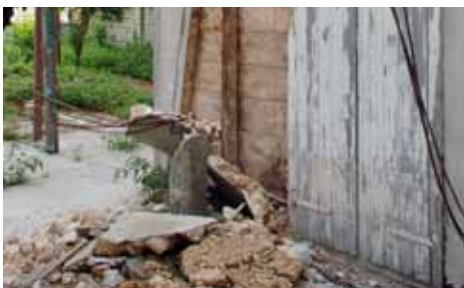
In places where masonry infill had been replaced with cement mortars or concrete block the infill would fall out as cohesive units which caused damage to roof structures below as they fell (Figure 88.) They also posed a falling hazard to persons below. Generally, soft fill like rubble stone in mud mortar performed better than hard fill (bricks in cement mortar) by absorbing energy. Hard fill usually failed en masse, rather than crumbling (Figure 89).

FIGURE 88 Stone infill that had been relaid with cement mortars would fall out of the wood frame voids in huge pieces during the earthquake causing damage also causing a safety hazard.

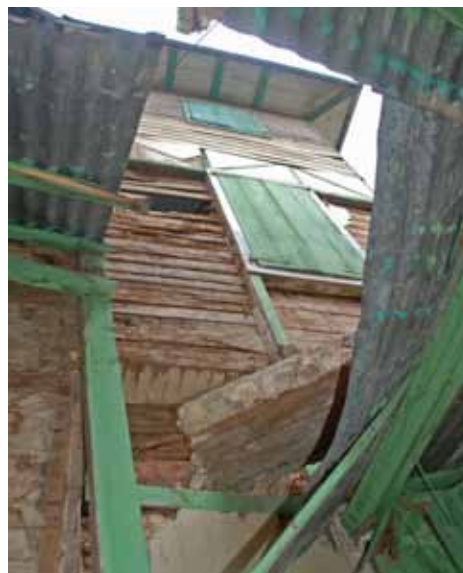
FIGURE 89 Brick infill that had been relaid with cement mortar fell out in huge pieces during the earthquake, causing damage to construction below.

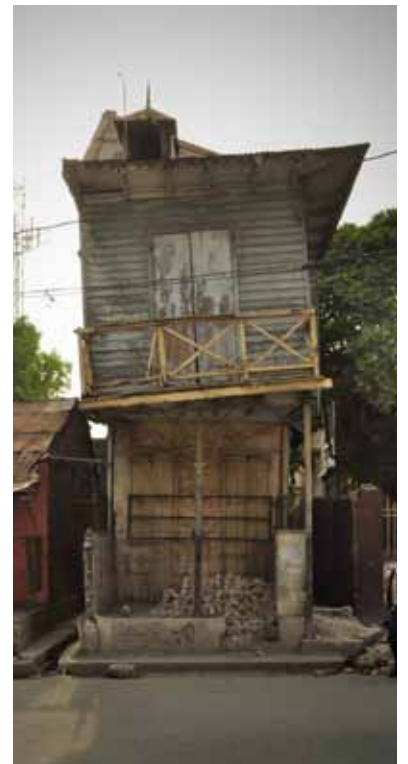
FIGURE 90 A wood clad and *colombage* structure of the most basic type on Rue Geffard near the National Palace. This structure appears to have been designed to be expanded to double its width, but never was. As a result, it was subject to the earthquake with a width at the base of less than 12 feet (3.6 meters). Also, at the time of the earthquake, it was in extremely poor repair. In spite of all of this, the earthquake did not cause it to collapse.

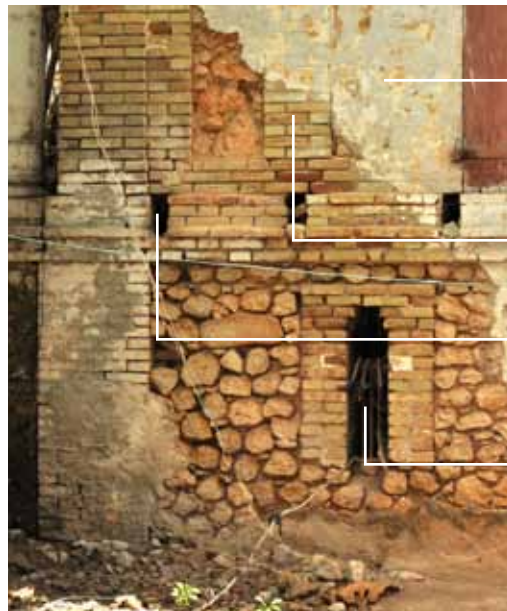
The finished plastered wall surface hides the substrate material from view. Years of rain and lack of maintenance have caused erosion on the building revealing the structure

Pockets for the floor beams; in many instances the ends of the beams showed extreme rot.

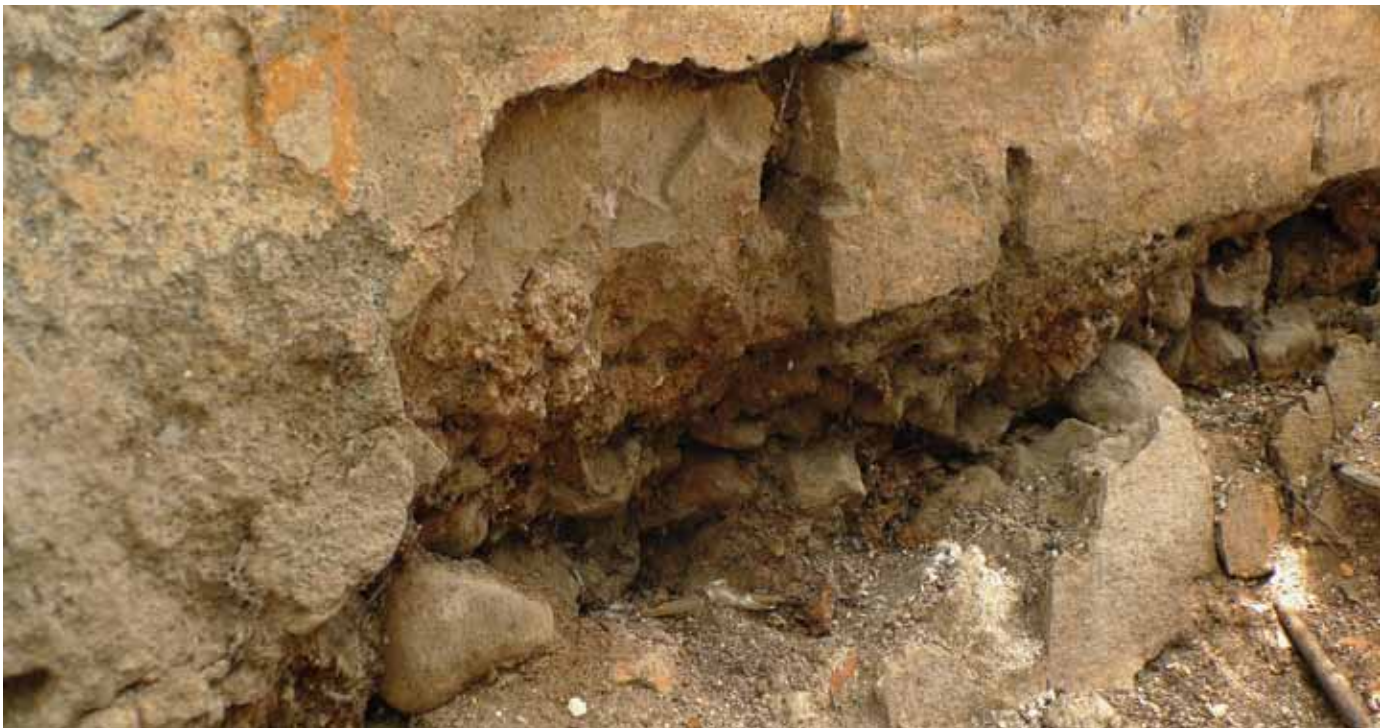
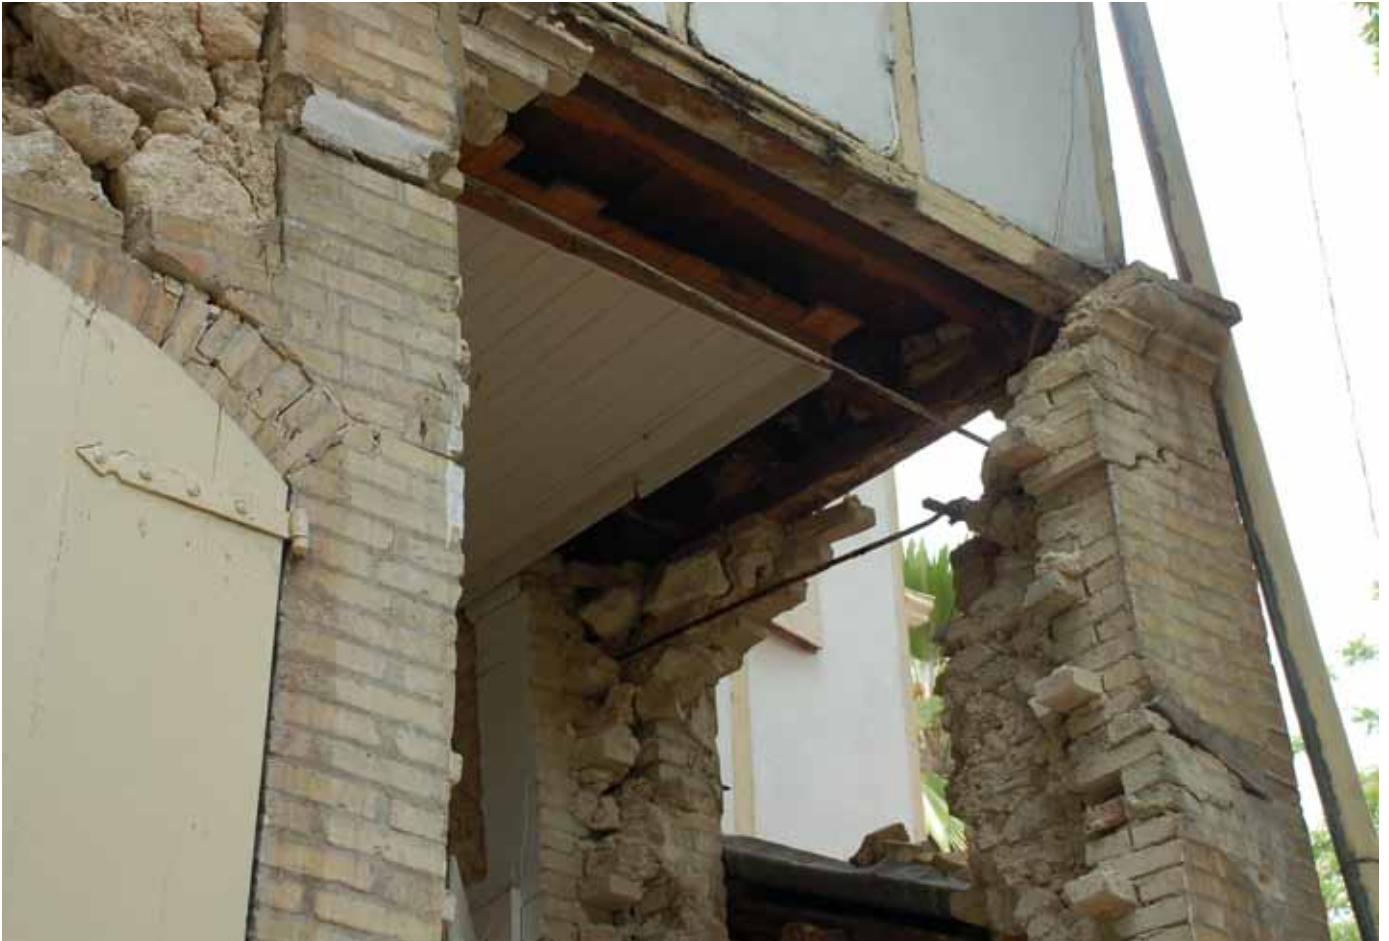
FIGURE 92 Basal erosion of the wall surface and foundation.

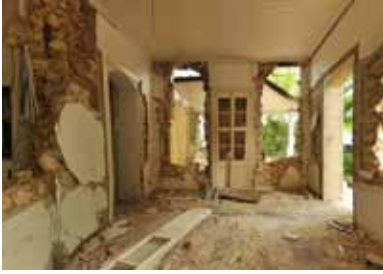
FIGURE 94 Ground floor interior of the Albert Dufort House on Rue du Travail Deuxième showing complete disruption of the rubble panels in its construction. The interior wall on the left, which did not have brick piers walls because of the lack of window and door openings, collapsed completely.

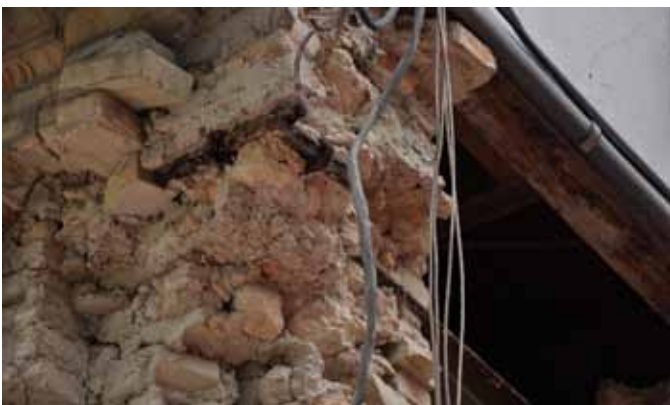
In a number of instances where the rubble stone panels were fully degraded or collapsed, the buildings (such as the Dufort House and Le Manoir) were saved from total collapse by the brick piers that surrounded and confined the rubble stone (see Figures 95 and 96). Unfortunately, this brickwork was not bonded one wythe to the

FIGURE 95 *above left* The Dufort House showing the collapse of the rubble panels, leaving the piers standing holding up the almost undamaged upper floor structure. The remarkably large pile in front shows the volume of rubble masonry removed from the house after it had collapsed. *above right* The interior of the Dufort House, also shown in Figure 77, showing how the collapse of the rubble panels left the house standing on the brick piers which were left like free standing columns. *left* This house also had steel or wrought iron reinforcing chains made up of rods hooked together for the full length of the exterior and major interior walls. In this case, rather than exterior plates to hold them, their wall anchors were imbedded under the outer wythe of masonry. The rods are also visible where they intersect at the corner pier that is still standing.

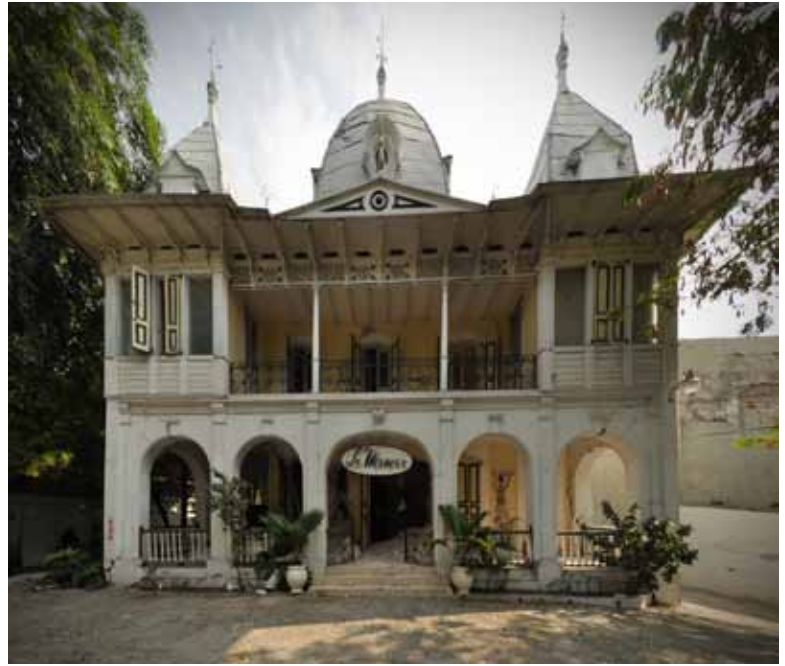
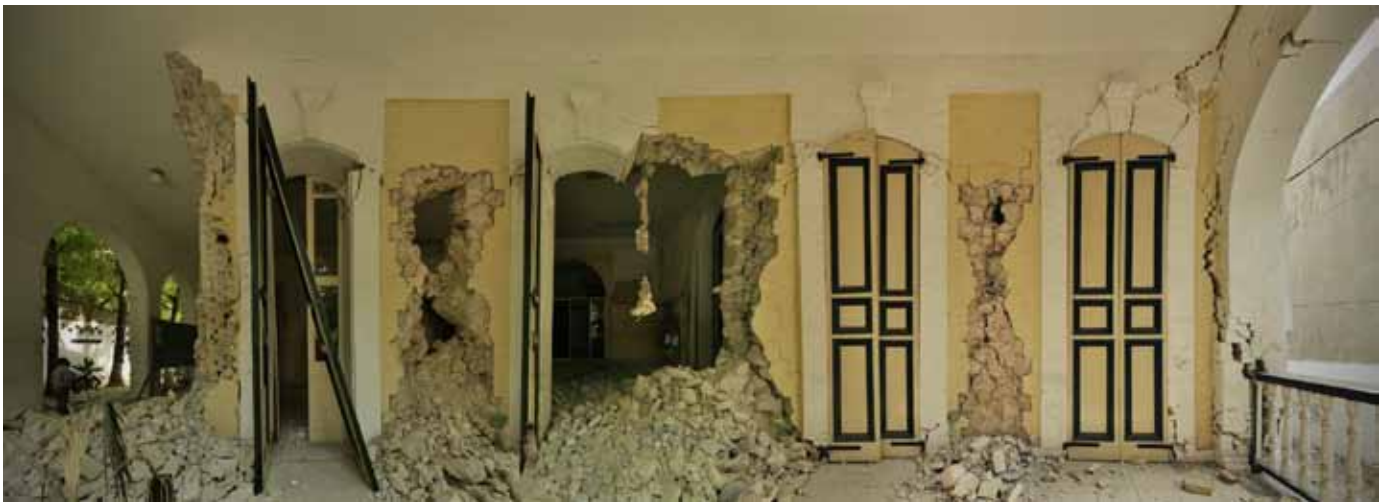
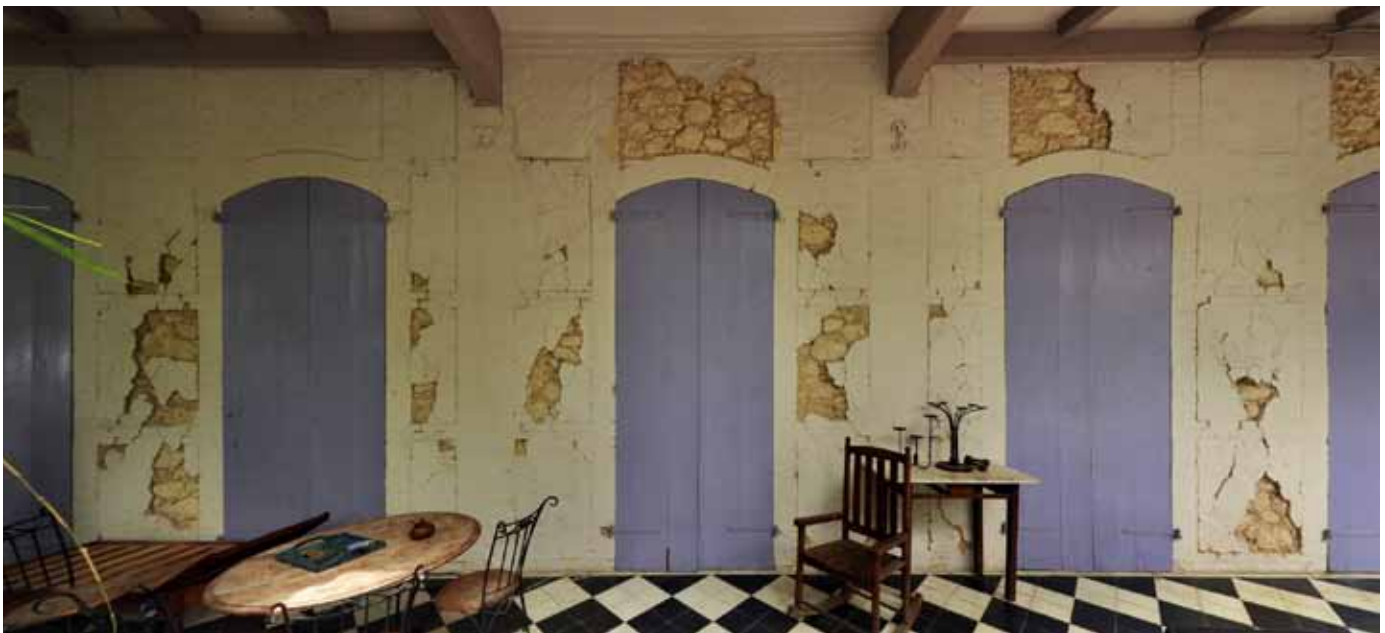
FIGURE 96 *top*: Exterior view of Le Manoir on Avenue John Brown. *middle*: interior view of Le Manoir showing a fully disrupted ground-floor wall where the rubble panels have collapsed, but the buildings remained standing on the brick piers. (view is a mosaic of several photos connected together). *bottom*: House at 65 Avenue N showing infill panels manifesting the onset of damage, but little displacement during the earthquake.

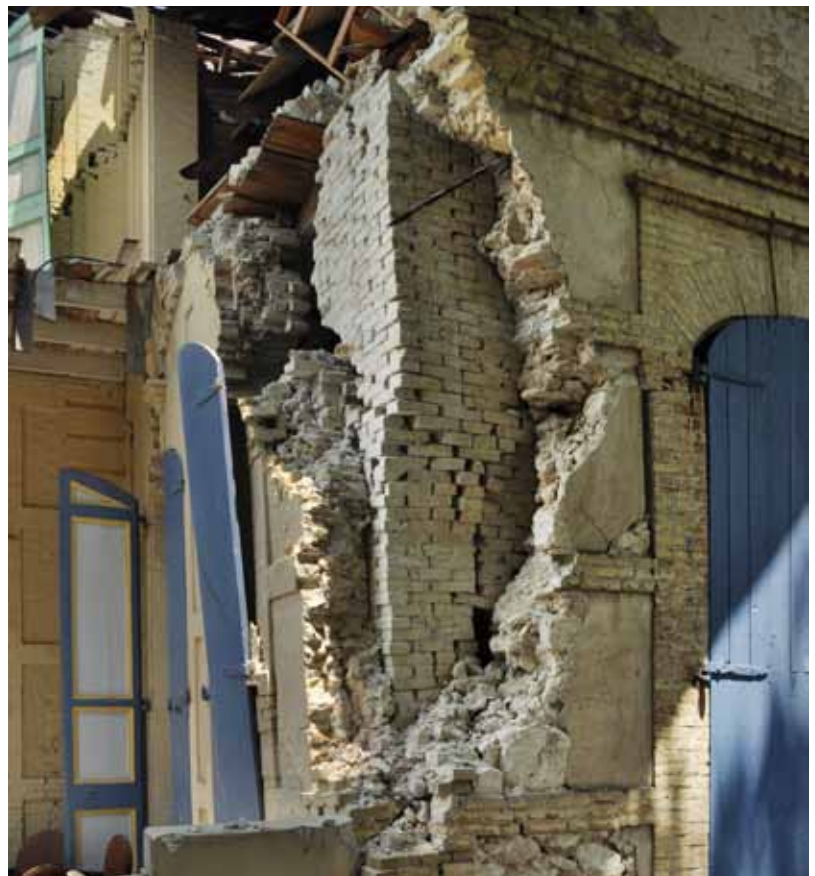
FIGURE 97 Two-story masonry house at 46 Avenue Christophe. During the earthquake, part of the second floor collapsed, followed by the subsequent collapse of the rest of the second floor. These photos show the ground floor, which remained standing, but with major rupture to the masonry walls, particularly at the corners. Right, the iron rod that had held the building together at the floor level is visible where it had failed because of corrosion. This image also reveals how the inner wythe of brickwork was not bonded to the outer layers of rubble stone. To form the inner corner of the room there is a layer of brick, whereas in the middle of the room, the rubble stone panel goes through the entire thickness of the wall.

next, so the piers have been shifted in those locations where rubble has been heavily disrupted or collapsed (see Figure 97). However, because of the horizontal bedding of the masonry, they remained stable. Walls that were disrupted to this extent will need to be rebuilt, and when rebuilt, a more stable masonry can be substituted for the rubble masonry. Since the rubble was always in recessed panels covered with plaster, substitution with better material should not result in a visual change.

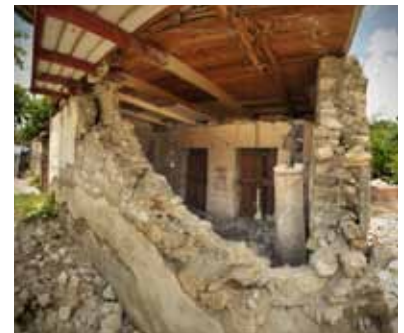
FIGURE 98 House in Léogâne where the solid rubble stone wall on one side partially collapsed, while the side with the two door openings with brick piers and rubble panels seen through the collapse remained standing with much less damage.

A comparative observation in Léogâne was of the performance of the walls with brick piers compared with solid walls of rubble masonry. One house there had a solid rubble stone wall on its south side without any penetrations by windows or doors, and on the north side, the wall had two tall door openings, which accounted for approximately 40 percent of the width of the wall, leaving three rather narrow piers that made up the remainder of the wall (Figure 98). The standard expectation of earthquake resistance would be that the south wall would be a more competent shear wall, and thus protect the structure from collapse better than the north wall. However, during the earthquake it was the south wall that failed, almost causing the collapse of the wood-framed second story, while the north wall showed the onset of damage to the rubble stone panels between the brick piers on the corners and surrounding the doors. This serves to reinforce the observations in the Port-au-Prince Gingerbreads, which have window and door penetrations on all sides: that the brick piers were crucial to protection against collapse, while the rubble stone was particularly vulnerable to collapse from earthquake vibrations. Moreover, this vulnerability was worse where the panel size was larger both in length and thickness.⁹ This is also
