Preserving Haiti's Gingerbread Houses

2010 Earthquake Mission Report

A World Monuments Fund / ICOMOS Project funded in part by Prince Claus Fund and FOKAL

**2010 Earthquake Mission Report
December 2010**

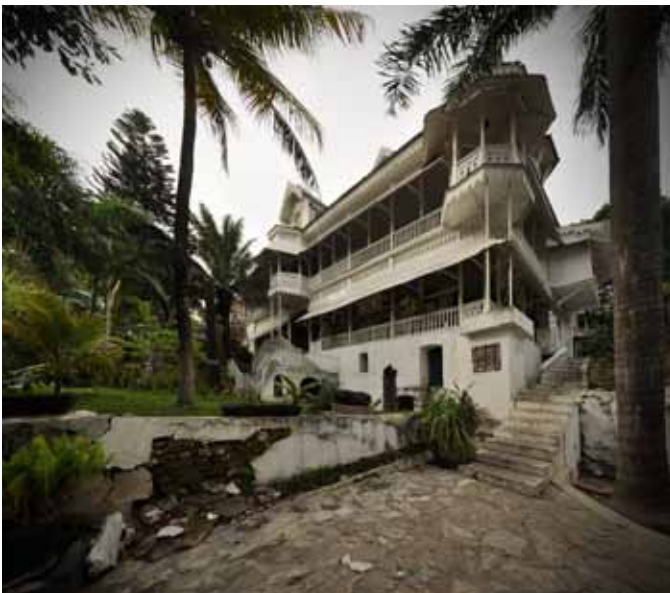
FIGURE 99 The Hotel Oloffson.

This building is constructed of brick masonry without the rubble stone panels. The masonry walls are hidden in the front by the wide wooden Gingerbread-clad porches, but are visible below.

cause it was constructed of load bearing masonry but without rubble stone panels. The walls appear to have been laid up in brick all the way through. The walls were of similar thickness (about 20 inches or 50 centimeters) as in other buildings, and the building is two stories on a high undercroft, so the loads were by comparison significantly higher than in most other houses, but the damage to this building was almost non-existent. Behind the Oloffson was a multi-story concrete hotel building that pancake collapsed completely, so there is evidence of considerable shaking at the site. The survival of the Oloffson Hotel in an almost undamaged state provides a good data point; it corroborates the observation that the greater damage to many of the other masonry buildings was largely a result of the unique weakness and vulnerability to blow-out of the rubble masonry panels.

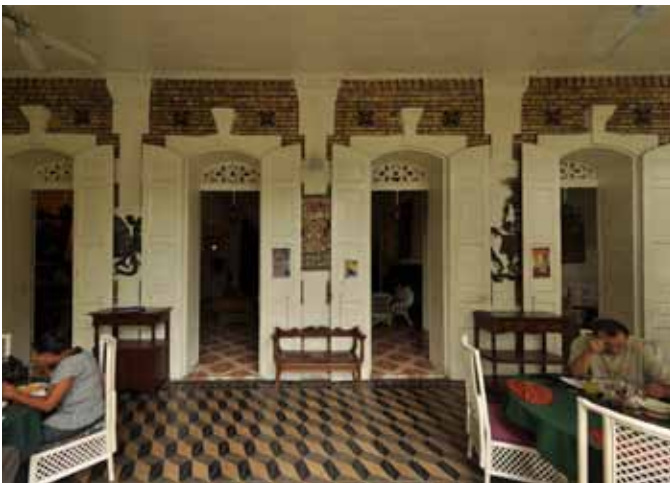
FIGURE 100 *left*: First-floor porch of the Hotel Oloffson showing brick façade with the many door openings that surround the building on all sides. *right*: Typical brickwork where it can be seen without the porches.

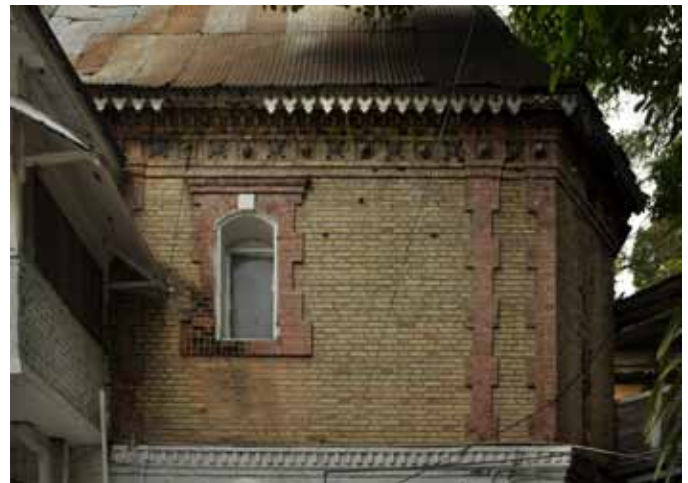
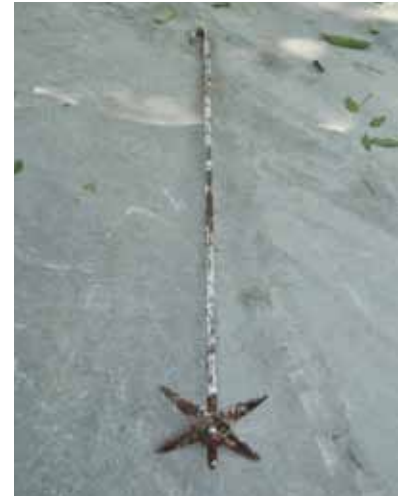
FIGURE 101: Iron chains are common in many of the masonry walls of the Port-au-Prince Gingerbread houses. Above is the first section of the chain with the star-shaped metal plate, and the view at left shows the metal plates where they remain holding the wall at the floor level in place, thus stopping the further separation of the walls at the corner. Had these floor level reinforcement rings not been installed, the lower floor walls would probably have collapsed as well.

A critically important protective feature of many bearing-wall masonry Gingerbreads is the “iron chains”—the iron or steel rods at the floor and roof levels that tied the walls together (Figure 101). Most of the rods that were observed in the survey ap-

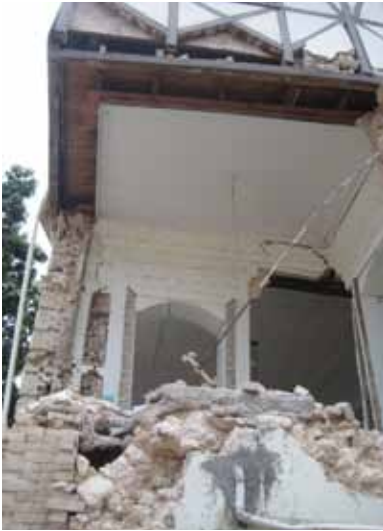
FIGURE 102 The horizontal metal ties within the masonry bearing wall probably kept this corner from collapsing entirely.

As noted by several team members, the role of these lateral metal ties in preventing even more severe damage is without question; the masonry buildings performed best when horizontal iron tie rods were present at the tops of the exterior walls (see Figures 102, 103, 104, 105, and 106). These rods were hooked together to form chains and laid into the masonry walls, typically spanning through the entire wall section in the center of the wall plane, usually at the level of a floor or roof. Many have ornamental plates at either end in the form of a star or something resembling a double-ended fleur-de-lis, while others were simply embedded in the masonry, though sometimes the embedded ends did not fully overlap at the corners. In examples where the plates

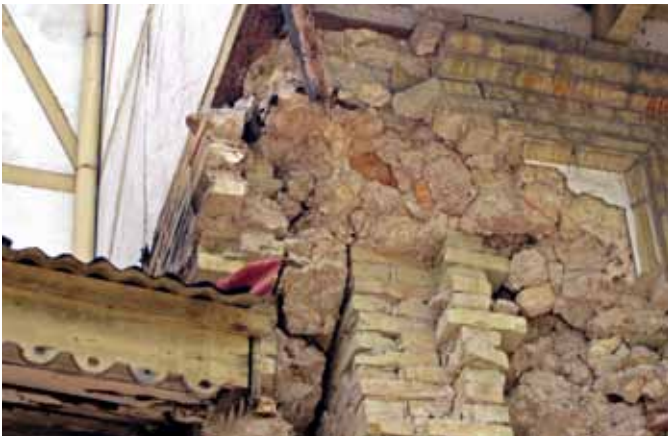
FIGURE 103 Embedded tie rods cross at the corner, anchored by iron bars. Also note rubble fill between inner and outer leaves of brick masonry.

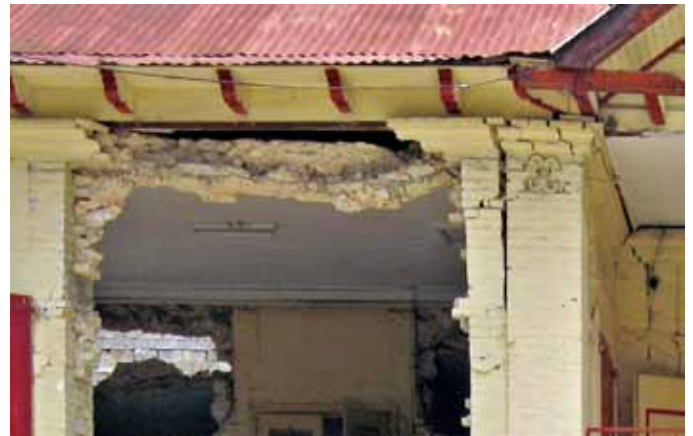
FIGURE 104 Total collapse was avoided in this heavily damaged masonry building due to embedded iron rods at the top of the walls, with exposed end plates.

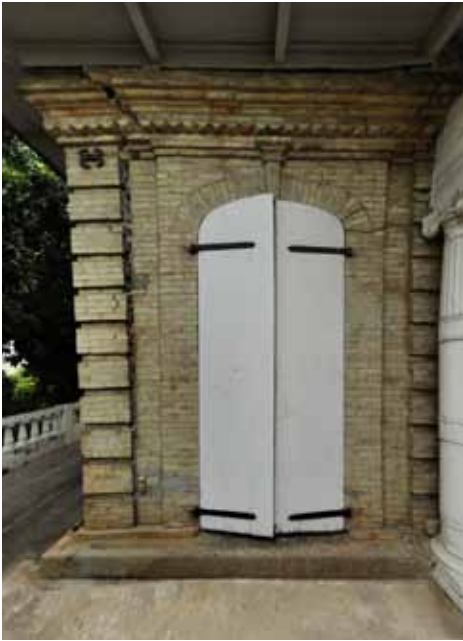
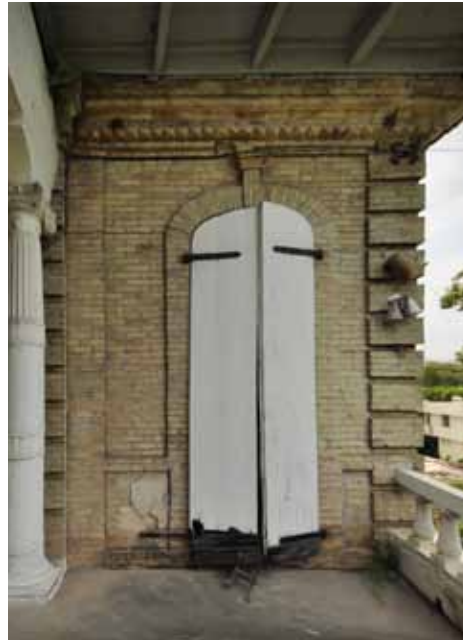
FIGURE 107 112 Rue La Fleur Ducheine, showing the metal plates at the end of the iron chains that are laid into the walls at the floor level. The end of the second floor wall on the left suffered damage because the plate around the corner to the left had fallen off probably because of rusting of the rod, whereas the plate on the right hand corner of the same wall shown on the right was intact, and thus the earthquake did not damage the wall at that end.

failed from rust or were not installed at the time of the building's construction, their failure/absence was associated with a greater amount of damage and disruption of the masonry (Figure 107). One good example is the Villa Castel Fleuri, where for an unknown reason rods were not installed at the corners of the second floor, but were installed at the first bay location and at the roof level. In this instance, the second floor corners were more dislocated by the earthquake than were other parts of the building where rods were present (Figure 108).

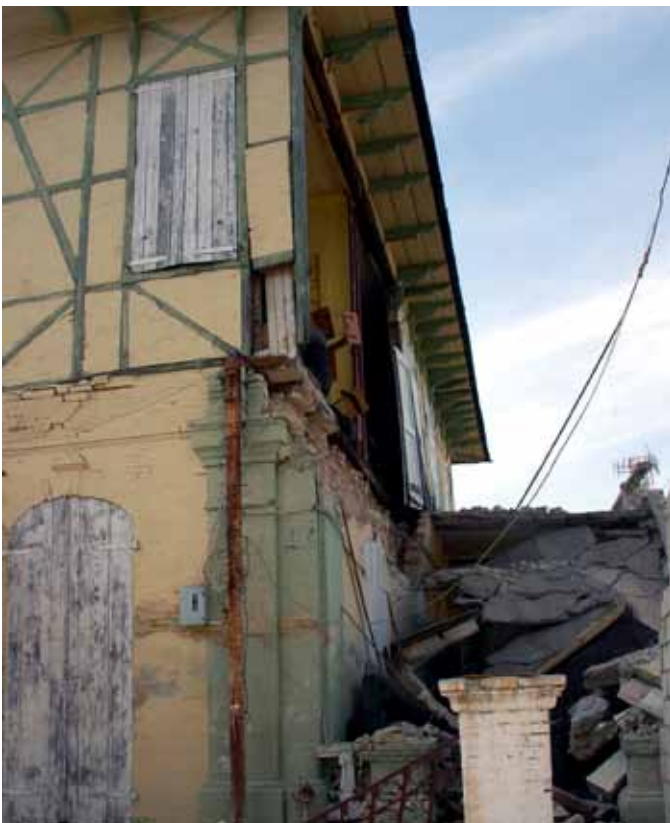
FIGURE 111 The wooden portion of this building remained standing, while the two-story concrete addition pancaked completely.

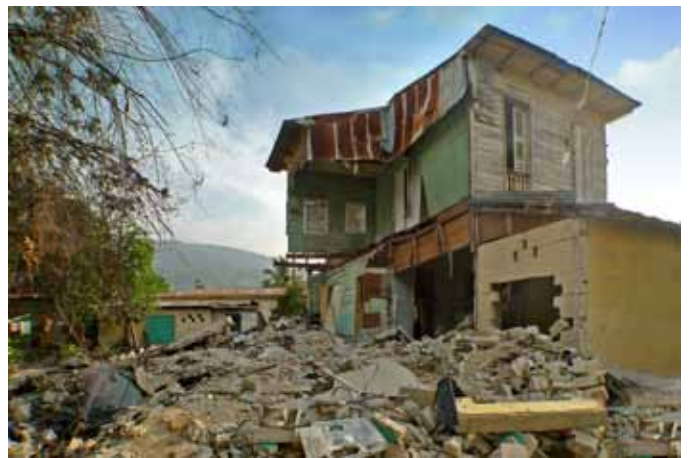
FIGURE 110 The concrete addition to the right of this Gingerbread house at 34 LaMartiniere collapsed and took down the second floor adjacent wall of the house as well.

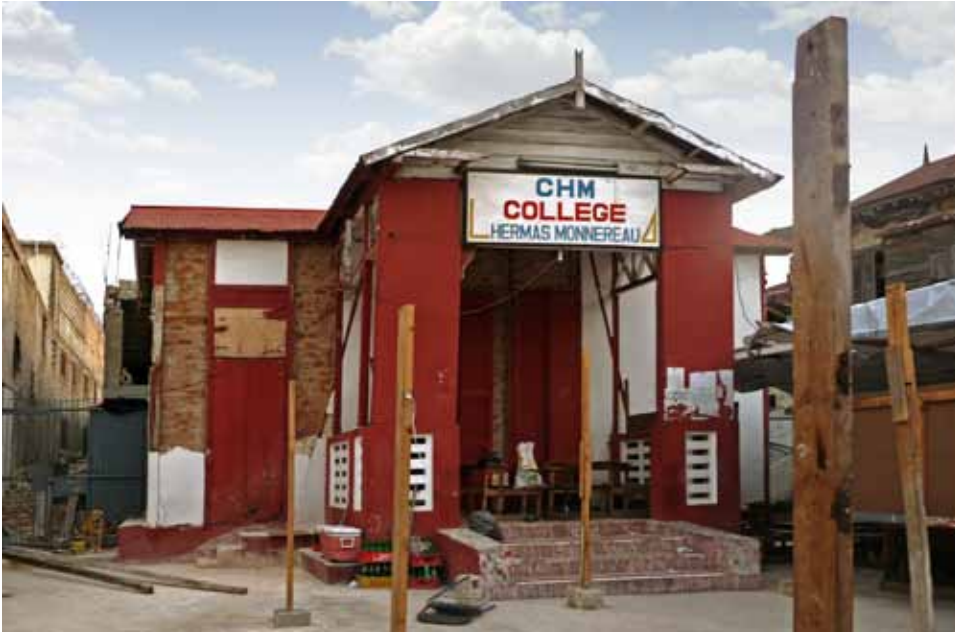
FIGURE 112 A small *colombage* school building at 16 Lamartiniere which had a two-story addition behind it. This addition collapsed completely, but the original building is still intact and in use.

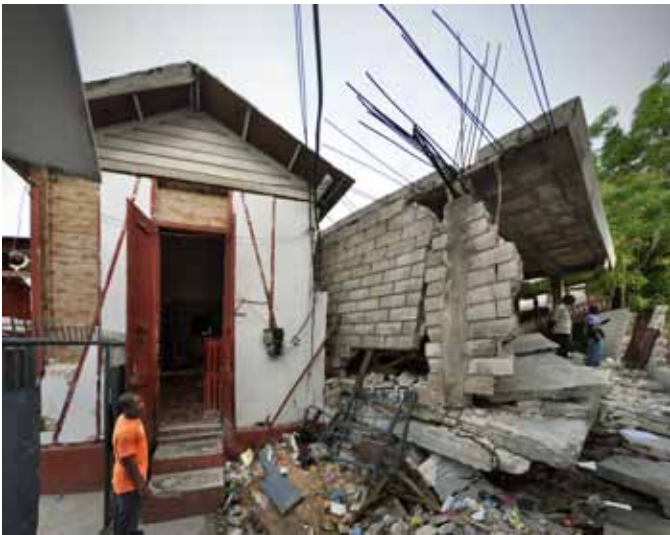
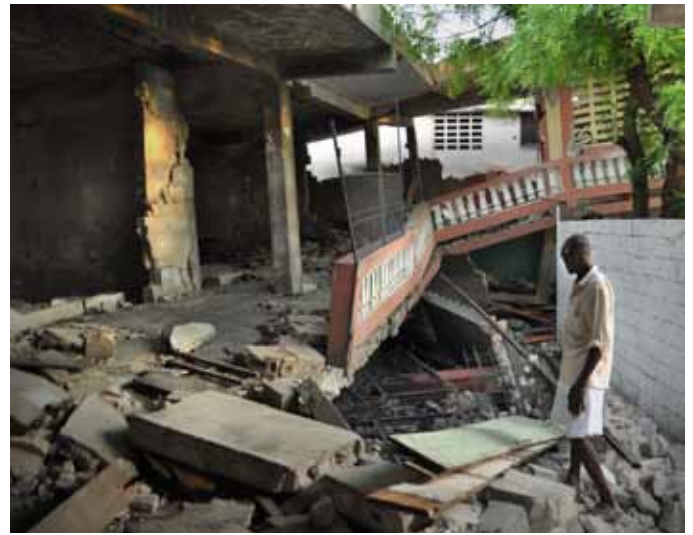
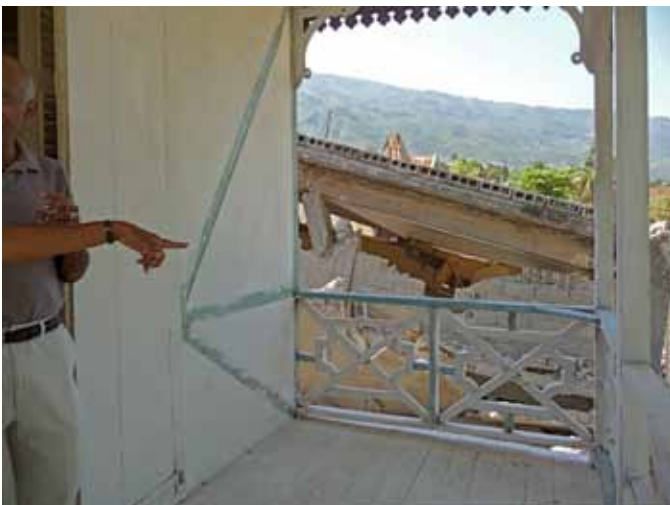
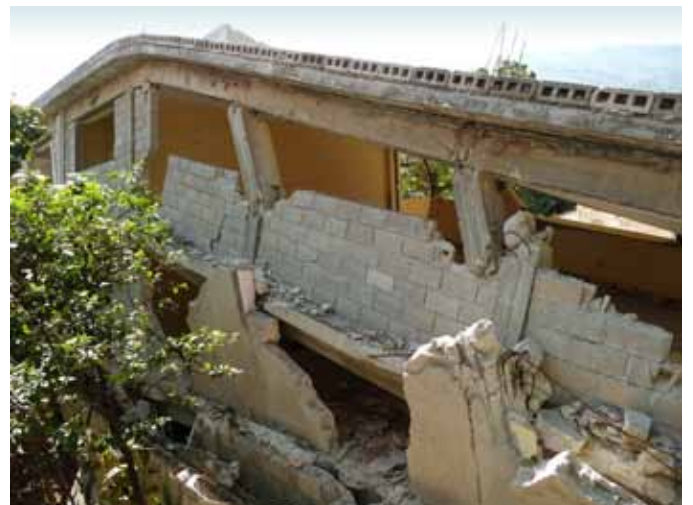
FIGURE 113 Owner of Rue 5 Jose Marti points to adjacent collapsed concrete and concrete block school building.

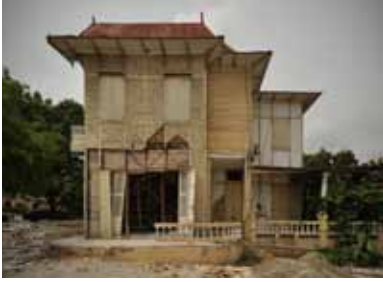
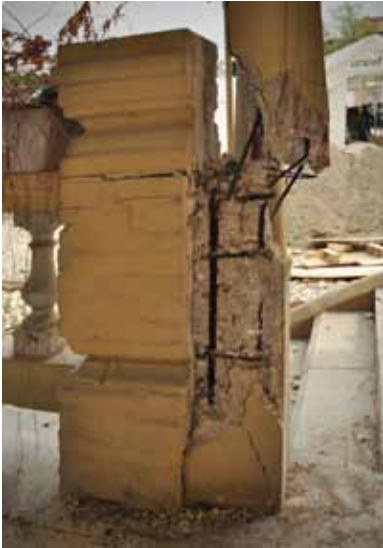
FIGURE 114 The Bazin House on Rue du Travail Deuxième. An upstairs bathroom of reinforced concrete and block construction clad with wood visible in the middle of the left photo almost caused the collapse of the entire house because it was standing on thin legs of heavily deteriorated concrete with rusted rebar. It was heavy, causing the whole house to sway, almost collapsing the bathroom wing, which may then have carried part of the house down with it.

These additions were often added for new kitchens or bathrooms, and thus were constructed with heavy concrete and tile interiors. When bathrooms were installed at the second-floor level, the additions sometimes were constructed on reinforced concrete legs, and thus their weight under lateral loads was imposed onto the historic house, leading to damage both to the addition and to the main house. One example of this can be seen at the Bazin House. Sometimes these additions were old enough to have suffered serious deterioration of the reinforcing due to corrosion. At the Bazin House, the legs that supported the second floor bathroom were broken by the earthquake, revealing that the reinforcing bars were seriously corroded, weakening the structure. This bathroom addition came very close to collapse and the house was badly damaged and out of plumb. (Figure 114)

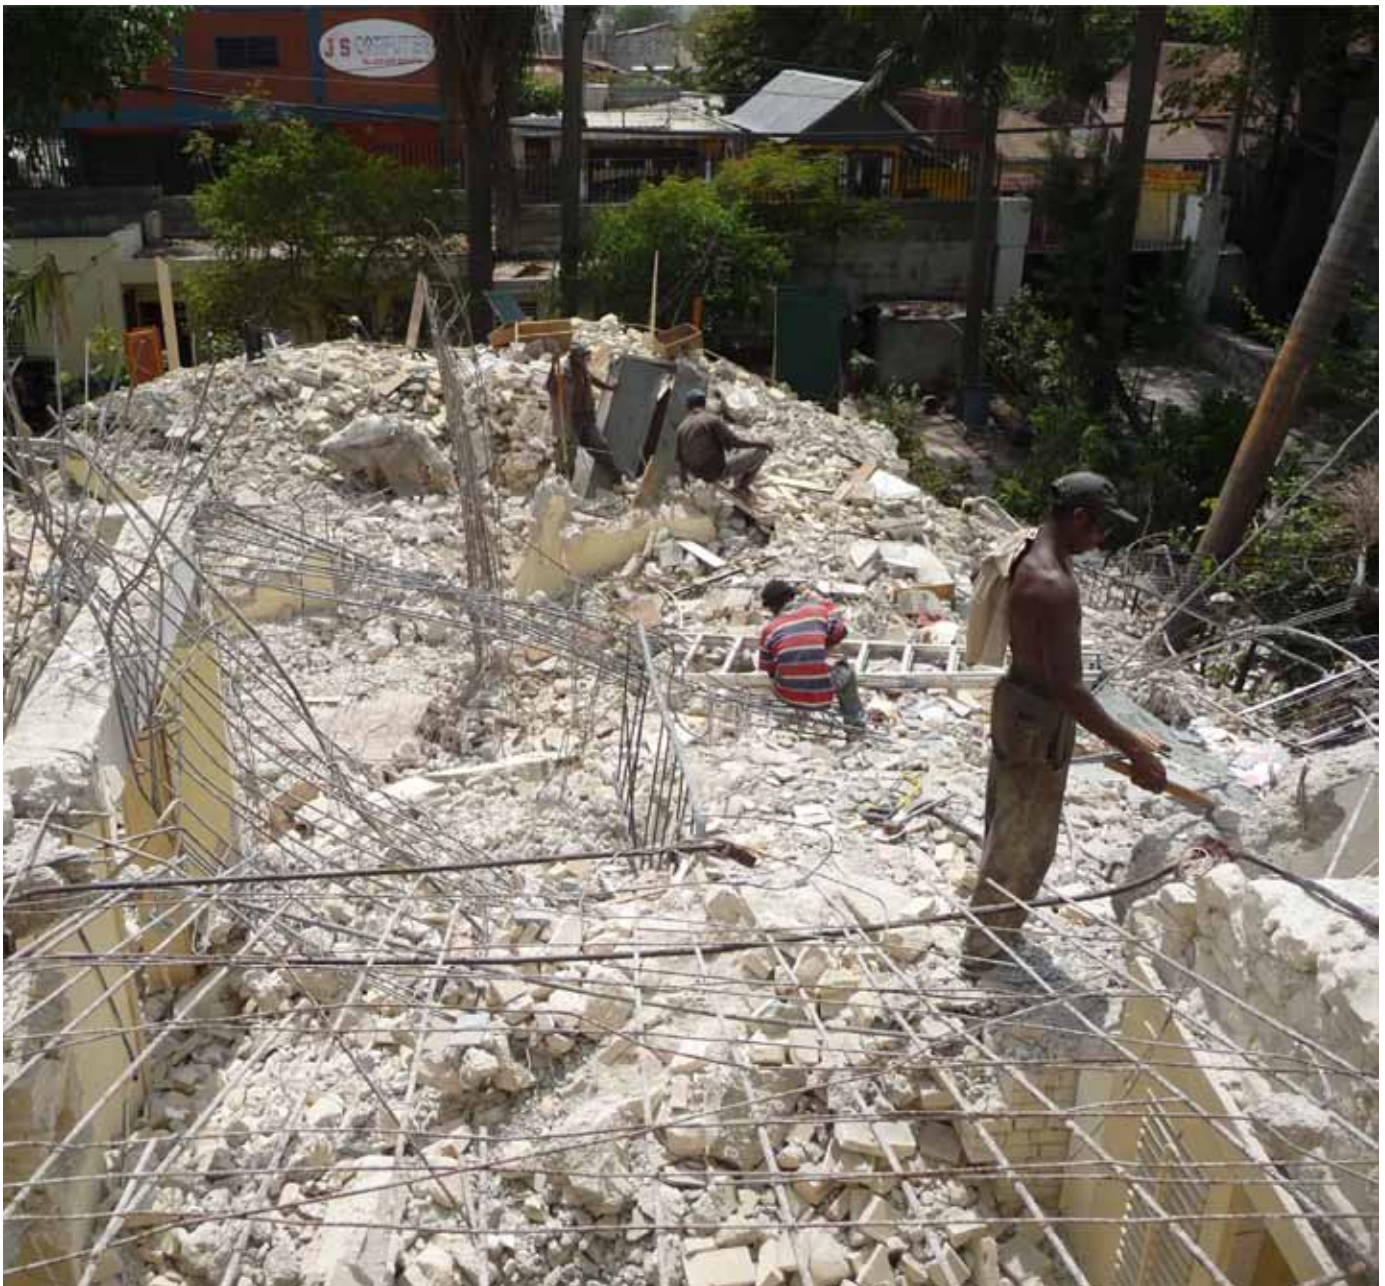
FIGURE 118 In a typical scene, a Gingerbread stands intact beyond the tragic collapse of a modern concrete building

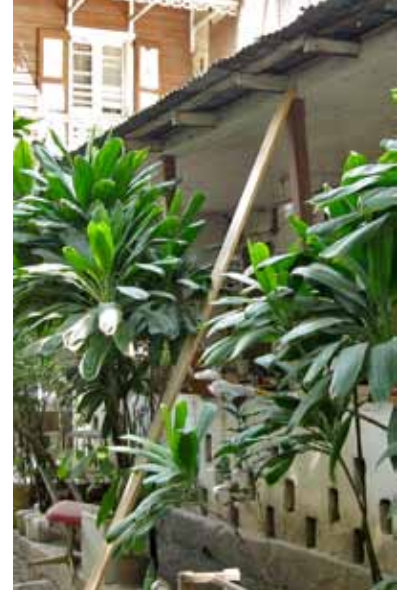
Team members observed that the shoring in place during the April mission was often under-structured and not configured correctly for best protection, whether due to a lack of resources or a lack of knowledge (Figures 119 and 120). This seemed

FIGURE 119 Temporary measures are important: this lateral brace is a good idea, but it is too slender and there is only one.

to be particularly true of lateral bracing, which is less intuitive to most people than vertical shoring. Training would improve the safety of this work. Also, it may be helpful to establish a group of contractors and assist them in securing shoring materials and equipment. In general, the team found that shoring should consist of timber (or other material) members leaning diagonally against a vertical wall to counteract the overturning action or placed vertically beneath a structure where the original bearing members or walls had been compromised. Other materials that are missing or in short supply include adjustable steel columns with threaded steel extensions, and polypropylene straps that can be wrapped around a structure. For examples of post-earthquake shoring in Italy, see Figure 121 and also: <http://haiti-patrimoine.org/wp-content/uploads/2010/02/ItalianShoring-MoliseEQ.pdf>

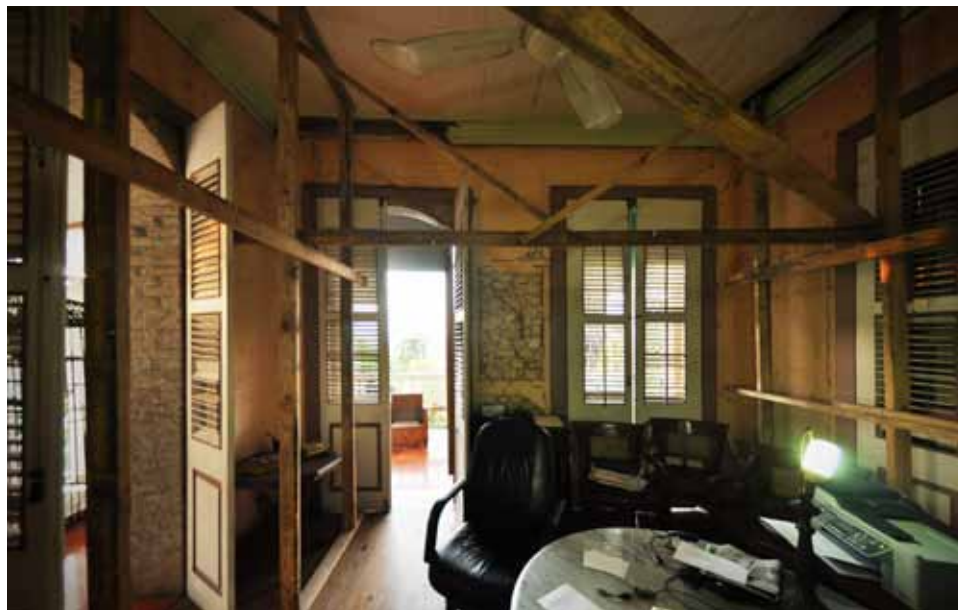
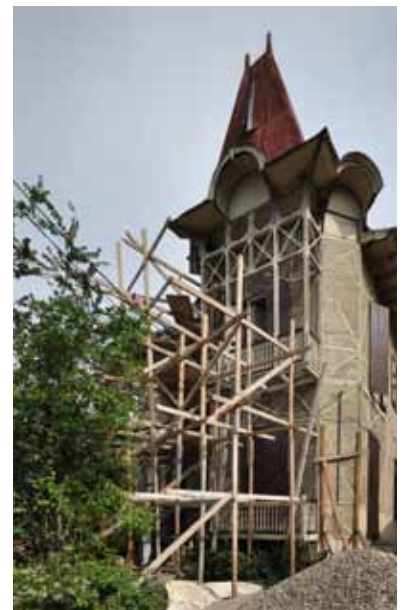
FIGURE 120 Scaffolding and shoring at 32 Lamartiniere, and shoring on the interior of 22 Rue Pacot.

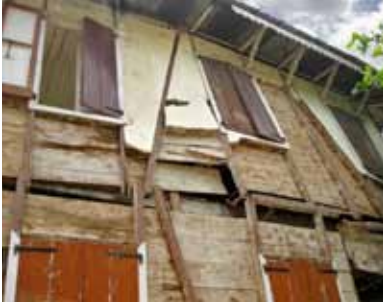
FIGURE 123 Typical vulnerability: the wall pulls away on the side parallel to the floor framing due to lack of connectivity between the floor and the wall. This is easily improved in most houses.

- Improve connectivity between various building elements. Mechanically connect wooden structures to their foundations, floors to walls, between wall framing members, and roofs to the building below (Figure 123).

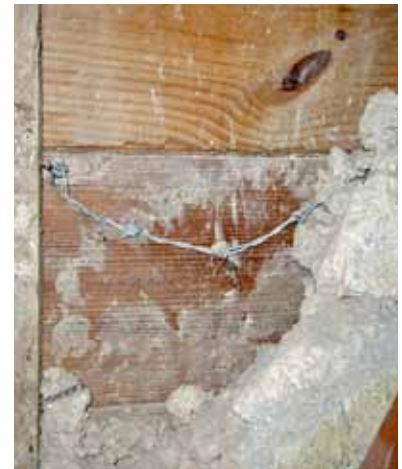
FIGURE 125 Barbed wire is frequently seen in the wall cavities as a restraint for the rubble fill. This is a good practice and should be continued.

- There is evidence in a few houses that the rubble stone infill masonry was reinforced with barbed wire at the time of the original construction. Continuing this tradition when rubble infill is reconstructed is advisable (Figure 125). Other types of mesh, including plastic geogrid, could be explored as a reinforcement, but barbed wire may be ideal for the following reasons: (1) it is probably widely available in Haiti for farming purposes, as well as security fencing, (2) it is almost always galvanized (which is essential if it is to be used for permanent construction), (3) it can be easily installed as the masonry construction is laid up. It is, however, recommended that a different configuration for its layout be used so as to improve the reinforcement effect. Historically a zigzag layout was used. If it is installed primarily as a horizontal bedding reinforcement with some strands crossing over the exposed exterior surface of the masonry (behind the plaster finish), then it can better hold the masonry in place.

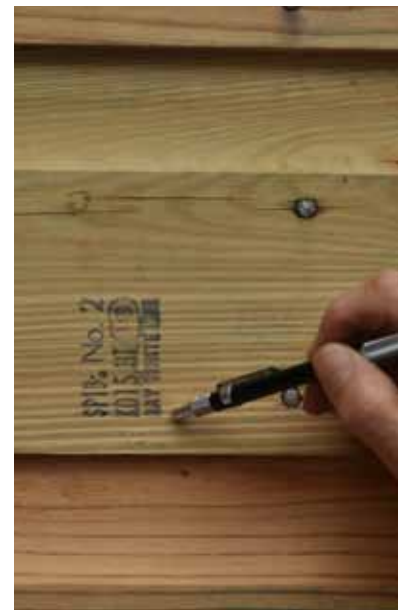
FIGURE 126 Owner and architect Gilbert Mangones explaining the restoration work he is doing on his house at 24 Avenue Lamartiniere, shown in Figures 1.18 and 1.23. The new ship-lap siding is pressure treated imported timber. The timber grade stamp is shown above.

- Replace damaged or decayed timbers (Figure 124). All newly added timber must either be natural heartwood from a species of tree known to be resistant to the local insects, or pressure treated (Figure 126). Because of the presence of toxic chemicals, pressure-treated wood should be painted when used on the inside surfaces of a house, and should never be used for kitchen cabinets or counter tops.

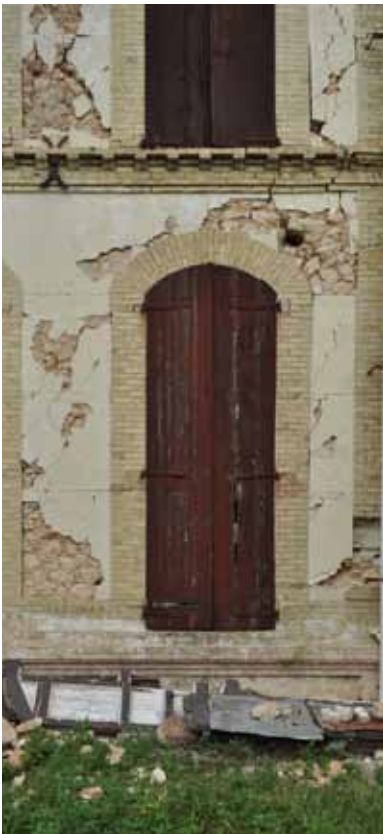
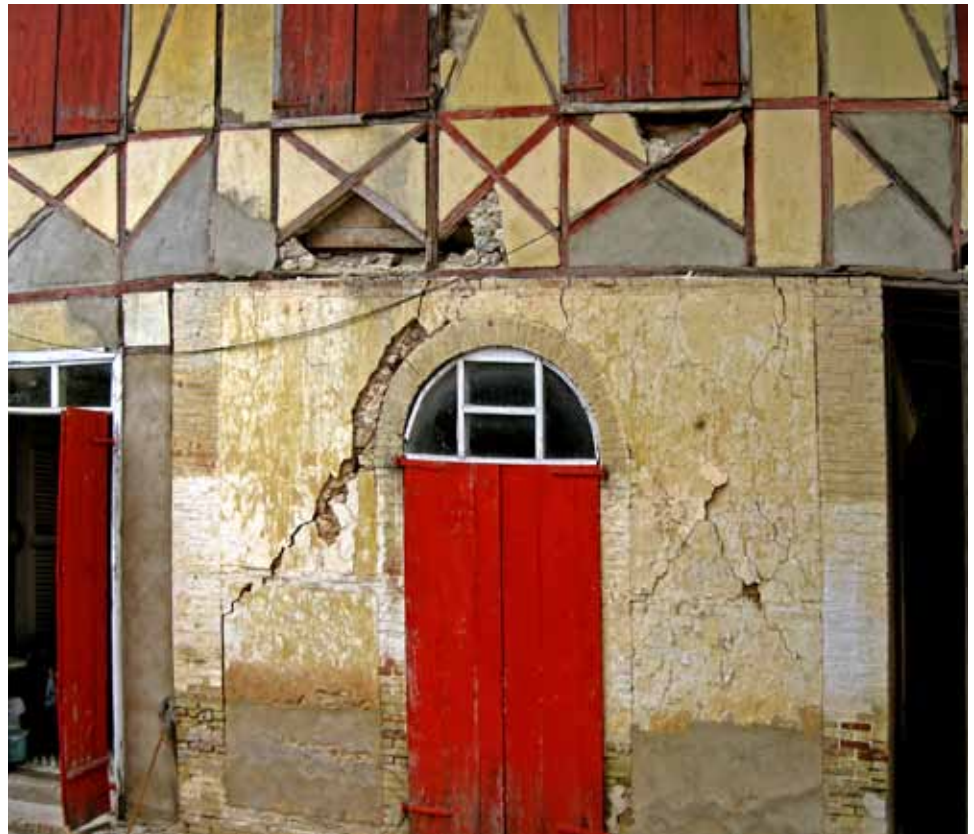
FIGURE 127 Typical 'brick frame' with rubble infill construction. Note crack pattern/energy absorption in rubble fill. Tying at the base of the arch will improve survivability

- Where missing or damaged, install tie rods at the top of walls, tying buildings in both directions and reinforcing arches and other openings as needed (Figure 127). Rebuild severely damaged areas. Inject cracks with lime grout. Only use lime mortar, not cement.
- Provide first-floor interior shear walls of timber construction, well-connected to the exterior walls, floor, and roof.
- Stitching of un-bonded multi-leaf walls may be needed in some cases.
- Restore timber floors that have been replaced by concrete.

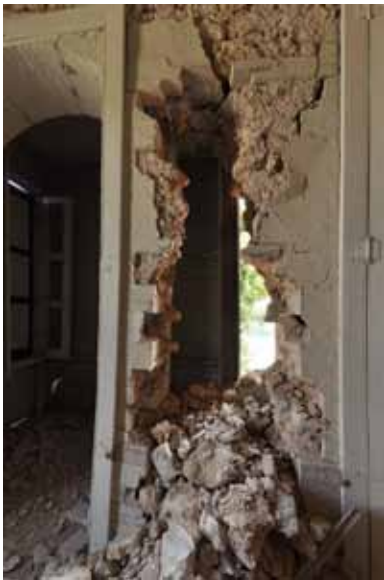
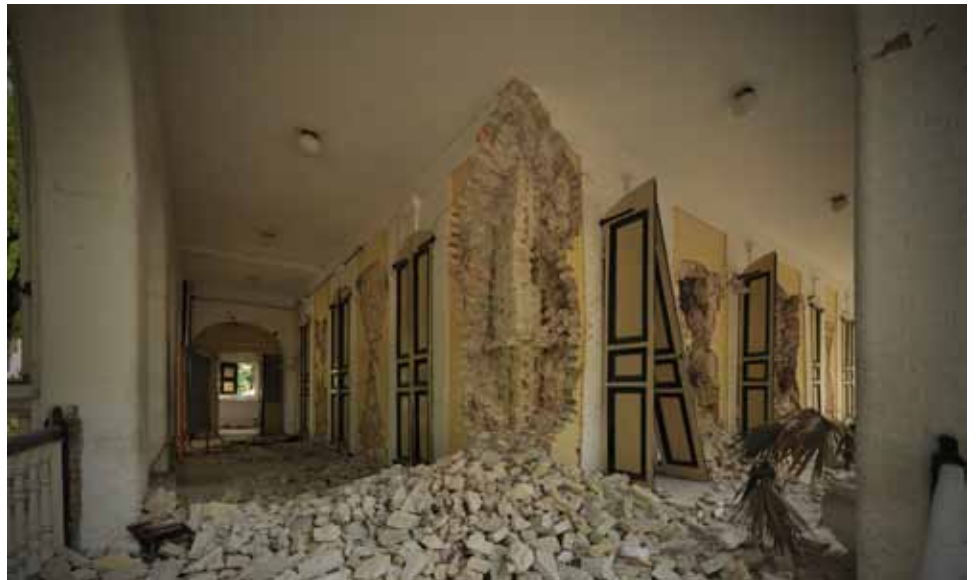
FIGURE 130 *below left:* Le Manoir on Avenue John Brown showing a heavy level of disruption of the masonry walls caused by the rapid degradation of the rubble stone panels during the earthquake. *below right:* A rubble panel on the second floor of the Villa Castel Fleuri that collapsed showing the displacement of the bottom of the brick pier into the doorway which resulted from the expansion forces from the panel.

- In the case of the Dufort House and Le Manoir (Figure 130), the damage consists of very heavy disruption to the masonry walls on the ground floor level—including dislocation of the brick piers as well as the collapse of the rubble ma-

sonry panels. The partial collapses of the walls have revealed that the brick piers themselves were not well bonded in their construction, and the mortar had become unusually weak and powdery. Repair essentially requires the re-laying and reconstruction of most of the walls of the ground floor level of the buildings. To accomplish this, a carefully engineered and constructed system of shoring will have to be undertaken, and then, section by section, the walls can be rebuilt. Considering the example of the Hotel Oloffson (Figures 99 and 100, page 48), the best rebuilding will be to carry the brick masonry throughout the walls, without the brick pier and rubble panel configuration. The architecture can be restored by recessing the panel areas and plastering that section. All brickwork should be bonded, so that all wythes are interconnected across the collar joints, the absence of which has contributed to the extensive damage in the earthquake.

- In instances where the rubble in a particular panel is heavily disrupted, with gaps appearing at the top or in parts of the panel, and a “belly” appearing in the middle of the panel from the expansion of the front to back thickness of the rubble wall, the best course is probably to dismantle and replace the panel. In such cases, in those instances where a “repair” approach (rather than a “restoration” approach) is to be taken—that is for non-museum level work on private homes—the replacement of the rubble panel with other material is probably the best course. Of the choices for masonry materials seen in Haiti, the small hollow clay tile bricks observed to be used in Haiti may be the best alternative because they are lighter than solid bricks. Because of their horizontal bedding and compatibility with the solid brick piers, they will perform much better in an earthquake than the rubble stone.

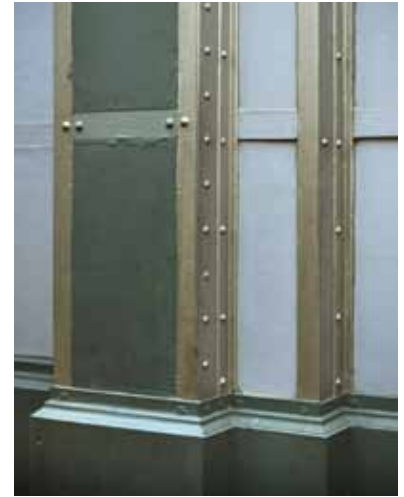
- Surface-applied steel reinforcement like that seen in the Saint Louis de Gonzague Chapel, and the small chapel next to the Cathedral (Figures 131, 132, 133), has performed well in the Haiti environment, probably because of protective coatings and subsequent application of paint. This kind of strategy can be considered, especially where the floor level chains are missing or corroded, and replacing them *in situ* internal to the wall is not possible. The remarkably good performance of those two churches could be considered an inspiration and a model for good performing masonry construction.

FIGURE 133 Saint Louis de Gonzague Chapel on Rue Du Centre after the earthquake. While the modern buildings of the Roman Catholic School collapsed, the Saint Louis de Gonzague Chapel survived without major damage. The Brothers of Christian Education founded the School in 1890, and the Chapel dates from after that date. This chapel is as large and tall as the nave of the Cathedral had been. Its iron frame, which serves to confine the masonry walls, was prefabricated in France. This structural system proved remarkably resilient compared to the early reinforced concrete construction found in the Cathedral as well as the National Place.

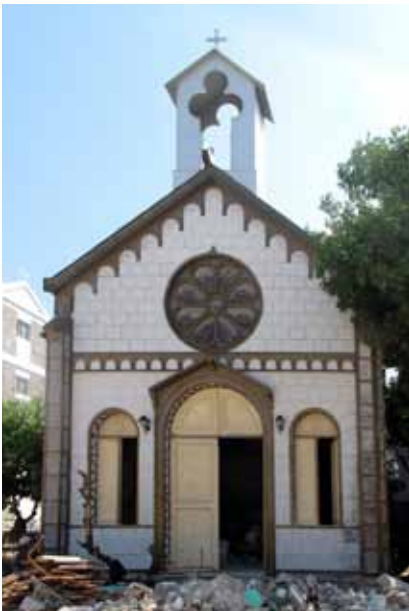
FIGURE 132 This small chapel next to the Cathedral has the same surface-applied steel reinforcement system as the Saint Louis de Gonzague Chapel and fared very well in the earthquake.”

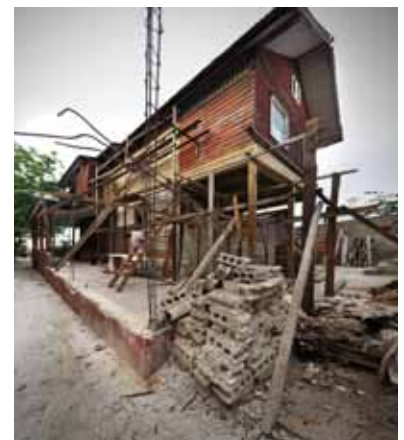
FIGURE 134 The modern reinforced-concrete frame with concrete-block back additions to the house at 24 Avenue Lamartiniere. The owner, architect Gilbert Mangenes, is now doing all of the repairs with timber framing and cladding, which will be much more compatible with the flexible timber frame of the original house, and less likely to collapse in a future earthquake.

To the extent possible, additions should be constructed of materials and structural systems compatible with the original house (Figure 134). Any additions not constructed of the same material and structural system of the original house — particularly when they will have a different lateral stiffness — should (1) be designed and engineered as separate structures with their own seismic system, rather than relying on the existing structure for either vertical or lateral support, and (2) be separated from the existing structure with a seismic joint. The seismic joint needs to be sized for the expected sway of both structures to avoid pounding, so that the two structures will not strike against each other during any future seismic event. It is recommended that a structural engineer be consulted to determine the size of this joint, and on the design of the floor and enclosure system on both sides of the joint. The joint can be bridged so that there is no gap in the weather enclosure of the house with its addition.

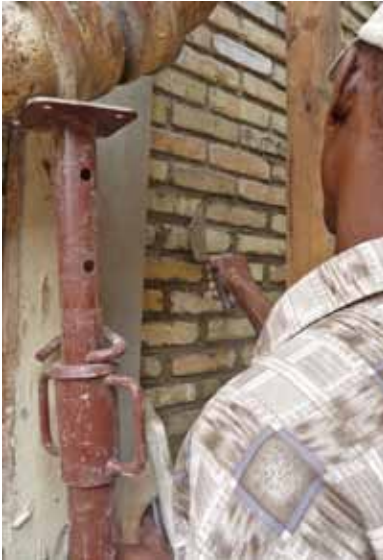
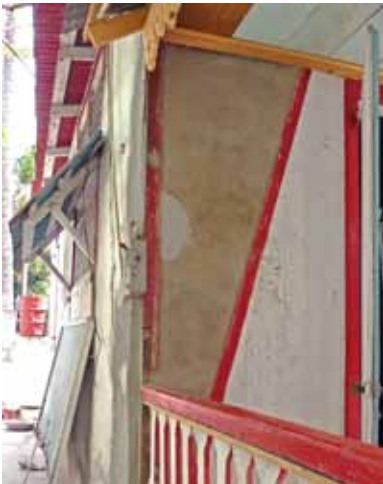
FIGURE 135 Well-intentioned but improper repairs with cement mortar in brick work (*left and center*), and cement plaster for *colombage* infill (*right*). Lime mortar and lime plaster should be used.

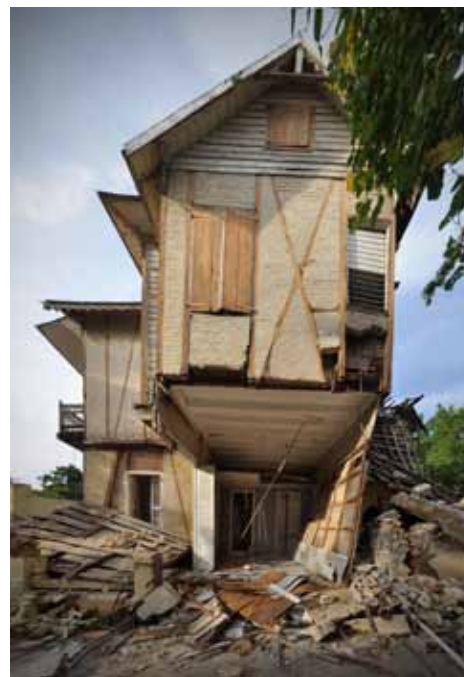
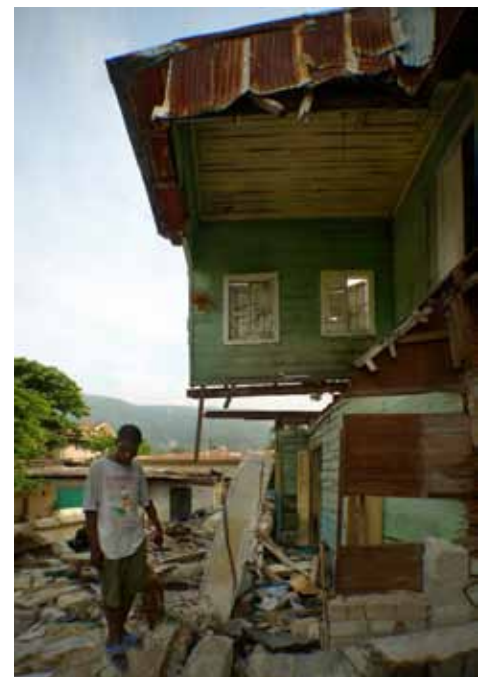
The countless concrete buildings that became death traps during the 35 seconds of the earthquake are the product of a process of building that betrayed the very people it should serve (Figure 137). In addition to their catastrophically poor quality in terms of safety, these concrete buildings have little of what can only be described as "spirit" or "soul." This becomes especially clear when compared with the ample spirit and soul proudly exhibited by the Gingerbread buildings.

FIGURE 137 *left:* House on Rue Jose Marti where the concrete addition collapsed, leaving the Gingerbread house cantilevered over the rubble. *Right:* The son of the owner of this house is pointing to the place where his brother remains buried in the rubble of the collapsed concrete addition.

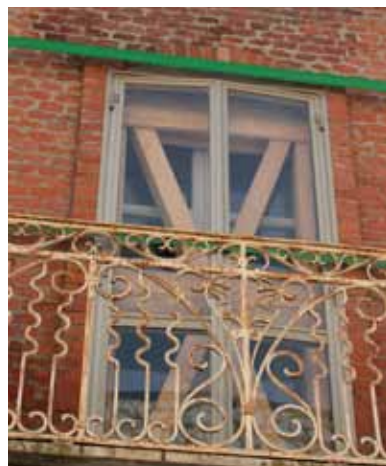
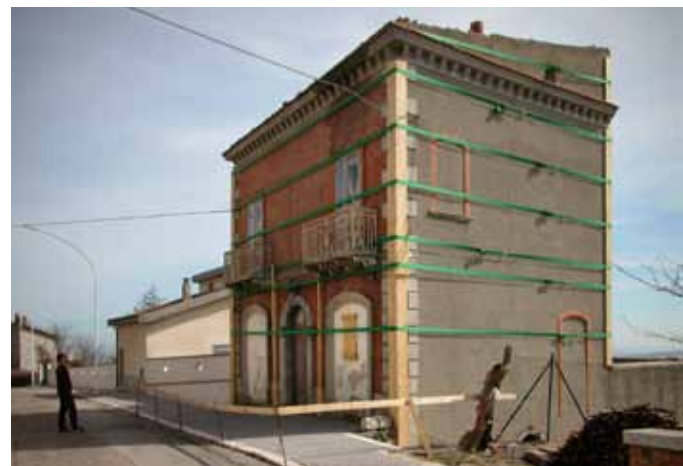
FIGURE 138 Examples of shoring constructed after the two recent earthquakes in Italy demonstrate different solutions to the important problem of stabilizing heritage structures to avoid emergency demolition for public safety. The two photos on this page show an unreinforced masonry building damaged in the 2002 Molise earthquake shored entirely with polyester straps, thus eliminating the need to block the street with diagonal braces. Shoring has been installed in the window openings—an important part of any system as it gives the damaged masonry wall structural continuity across openings.

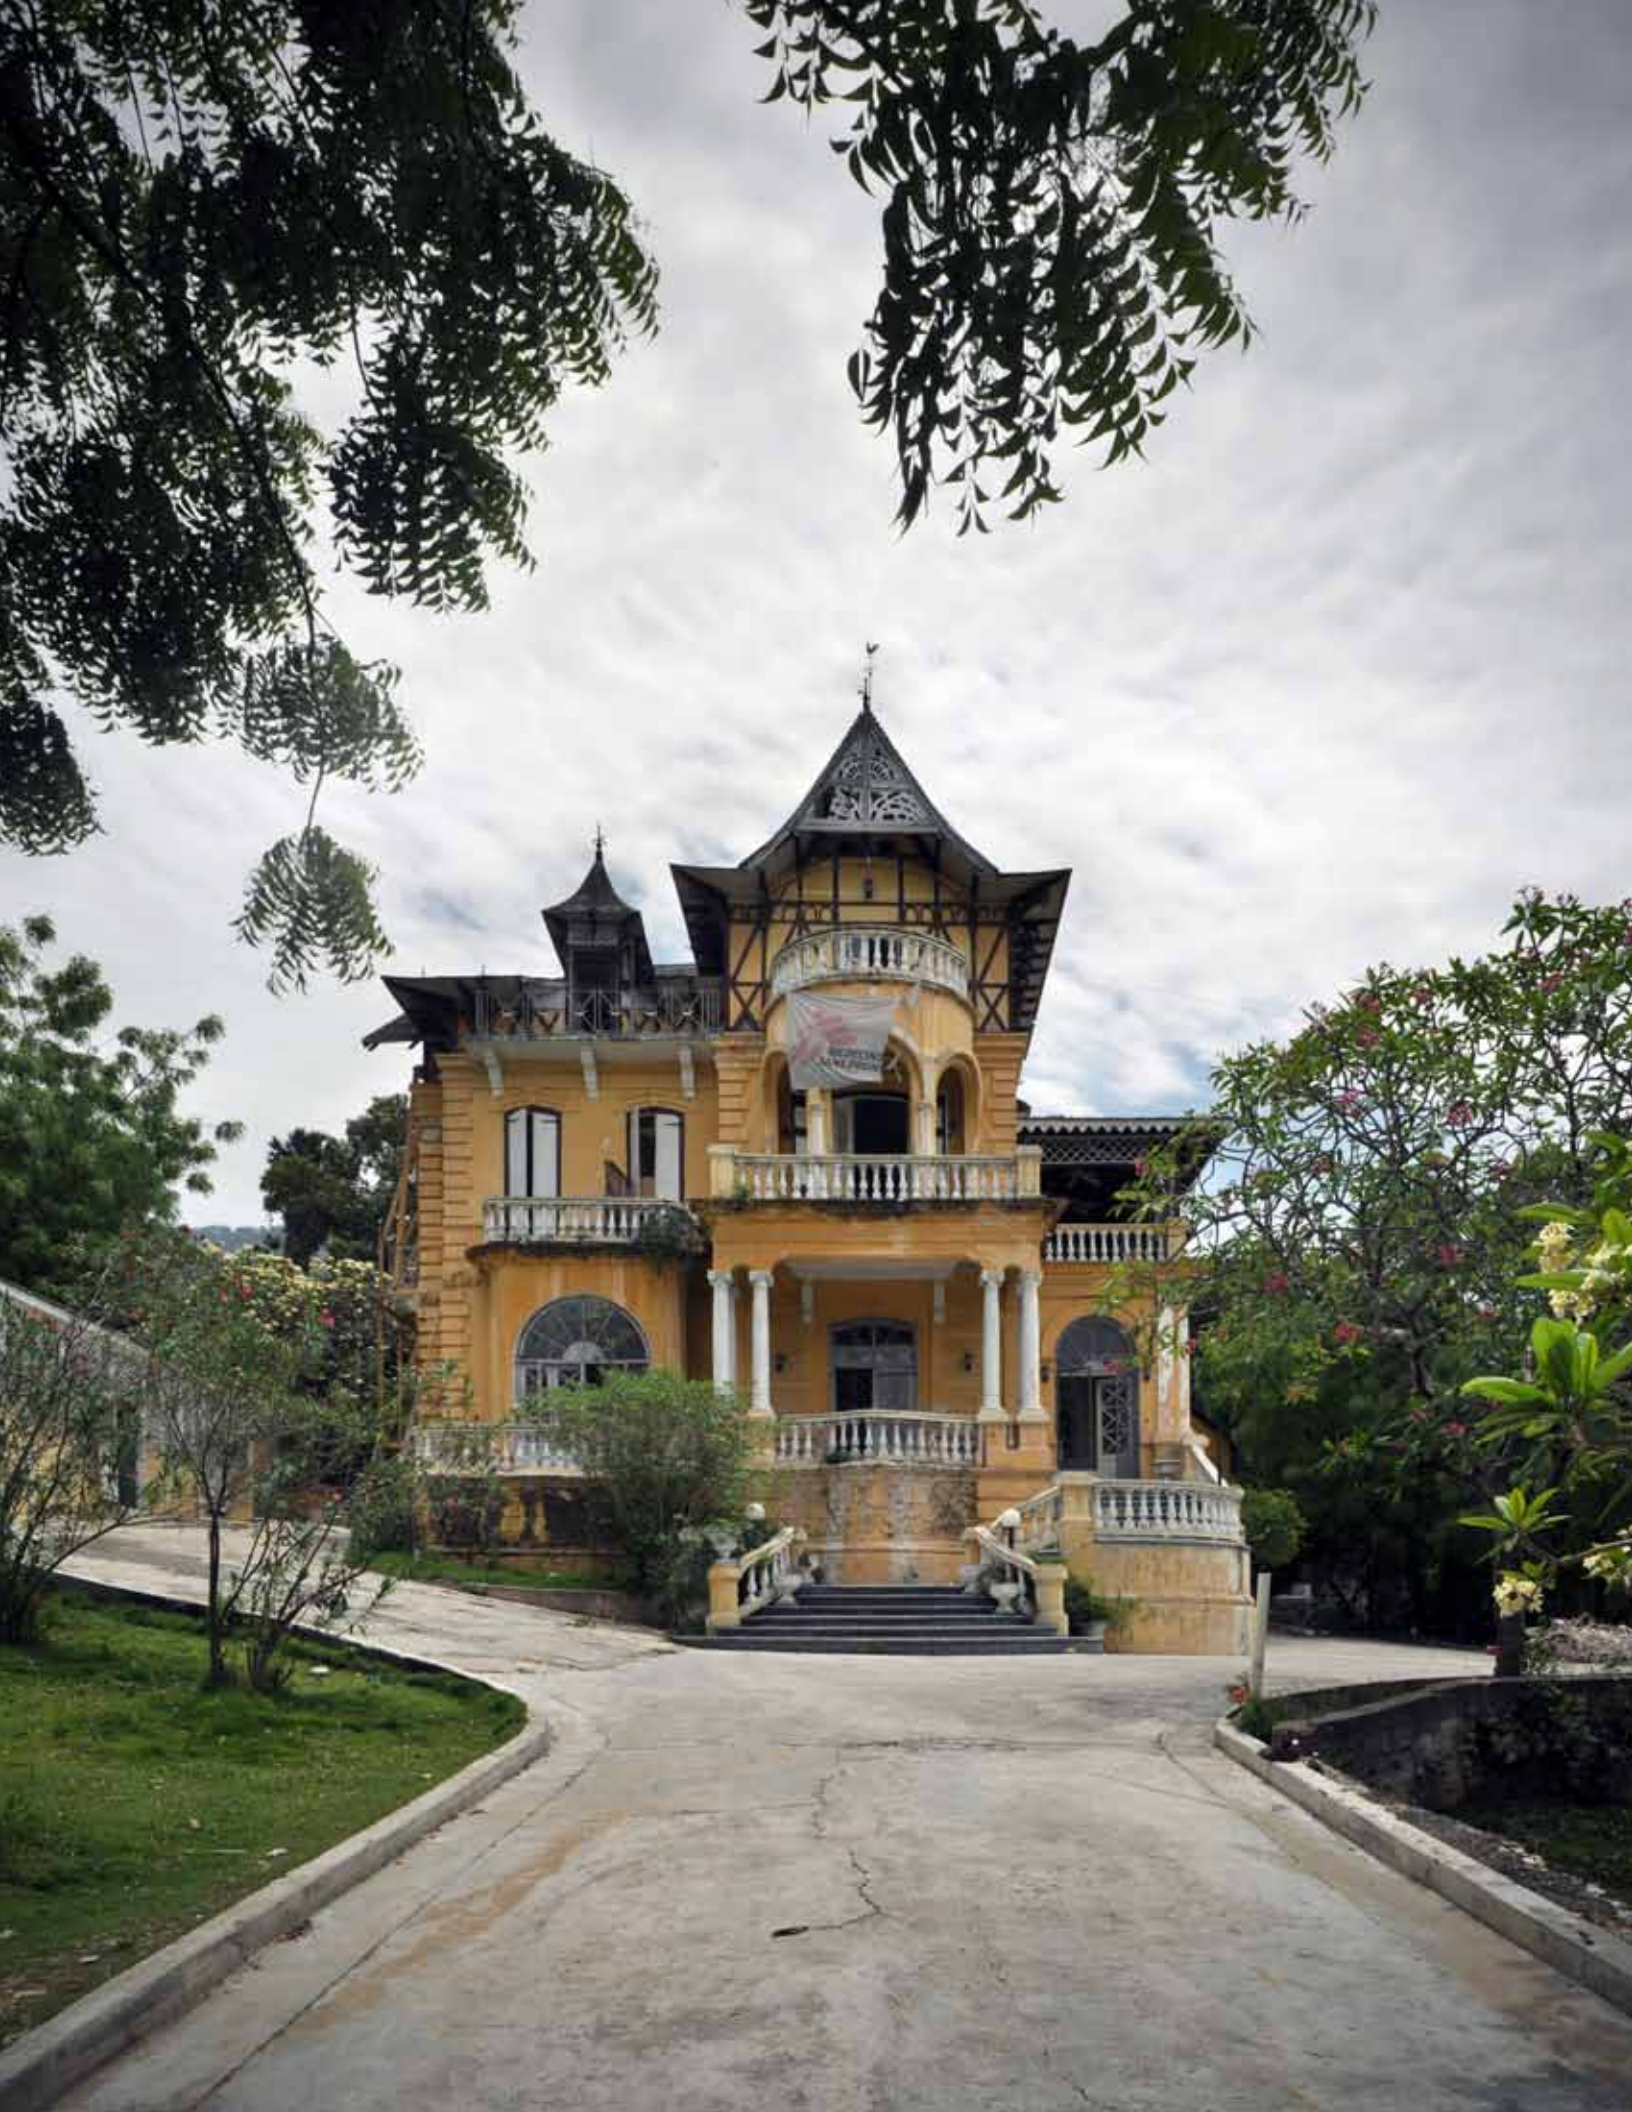
FIGURE 141: *back cover* A splendid mansion of masonry construction on Rue 4 Pacot occupied at the time of the earthquake by Doctors without Borders. The house generally suffered only a moderate amount of damage, but the back masonry wall separated from the frame at the third-floor level. This may have been caused by the later construction of a bathroom with a raised concrete floor.
